Remains of a timber-framed building at Howards Farm, Eccleston, St Helens

Robert Philpott

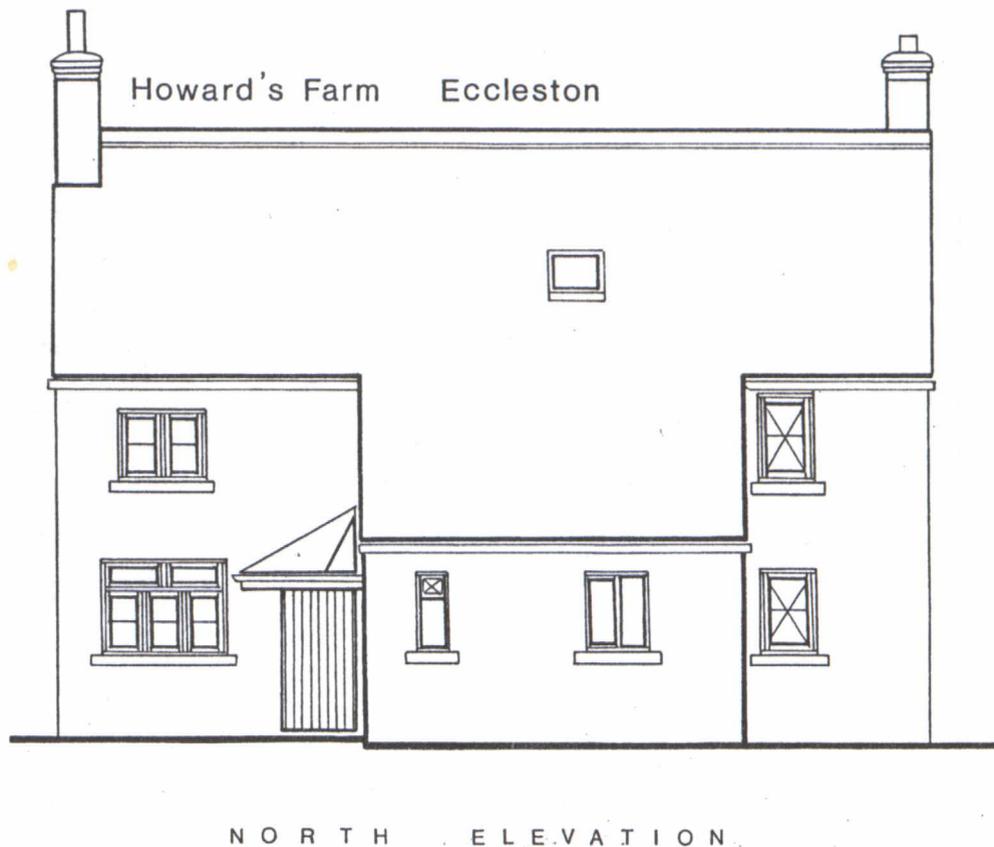
Figure 29: North elevation.

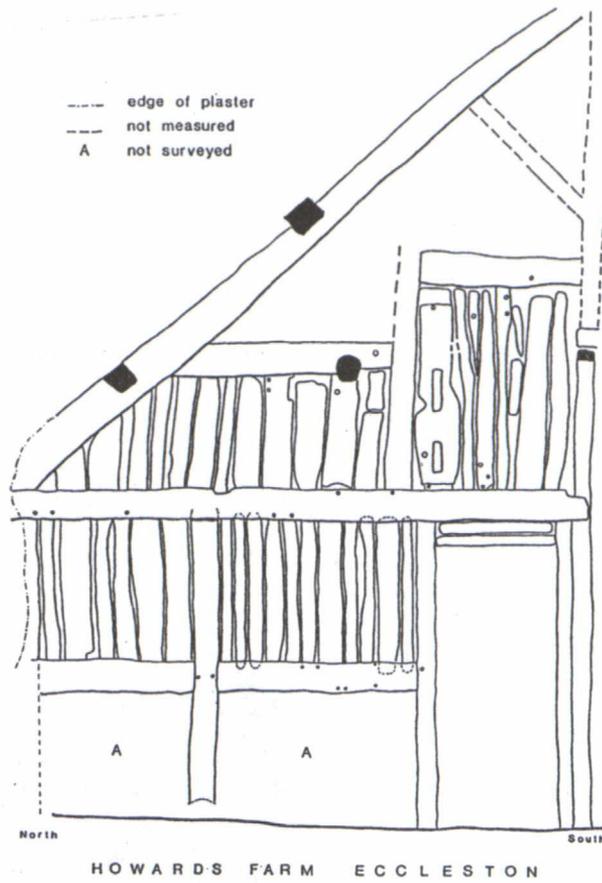
removal of both part of the northern rear wall and the entire west gable wall due to severe structural problems revealed that the rear wall was constructed of small sandstone blocks, virtually without foundations and of an earlier phase than the brick portion. Within this stone structure a section of timber-framing had been uncovered west of the staircase, on the northern side of the building (Figure 30).

The surviving timber framing consisted of a box-framed construction with a horizontal tie beam, a substantial principal rafter, and probable queen-post roof structure, although the details of the last point were not clearly visible and could not be accurately measured (Figure 31). The box-framing had been sawn in half when the brick front part of the house was extended, and a new vertical post inserted to support the queen post after the removal of one side of its

supporting frame. The infill of the panels consisted of split staves, including a number of reused short pieces of an earlier frame, slotted into grooves cut into the upper and lower faces of the horizontal members. This had then been covered with daub and later with horse-hair plaster.

Figure 30: The timber framing west of the staircase on the northern side of the building.

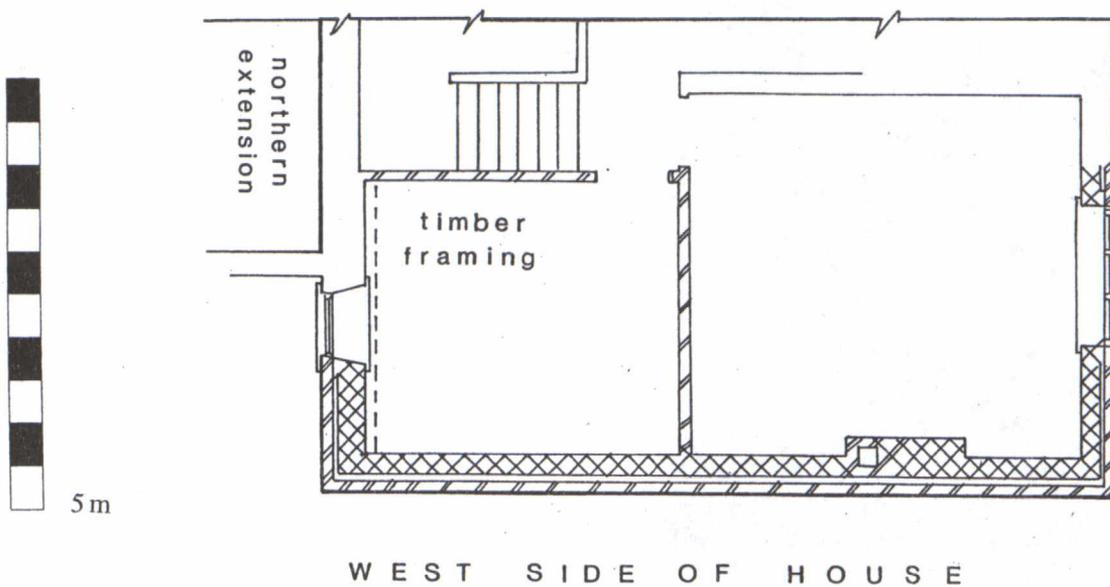
Figure 31: Plan of the 18th-century and earlier house showing the location of the timber framing.
