BUILDING SURVEY AT THE SCOTCH PIPER INN, 1985

Jennifer Lewis

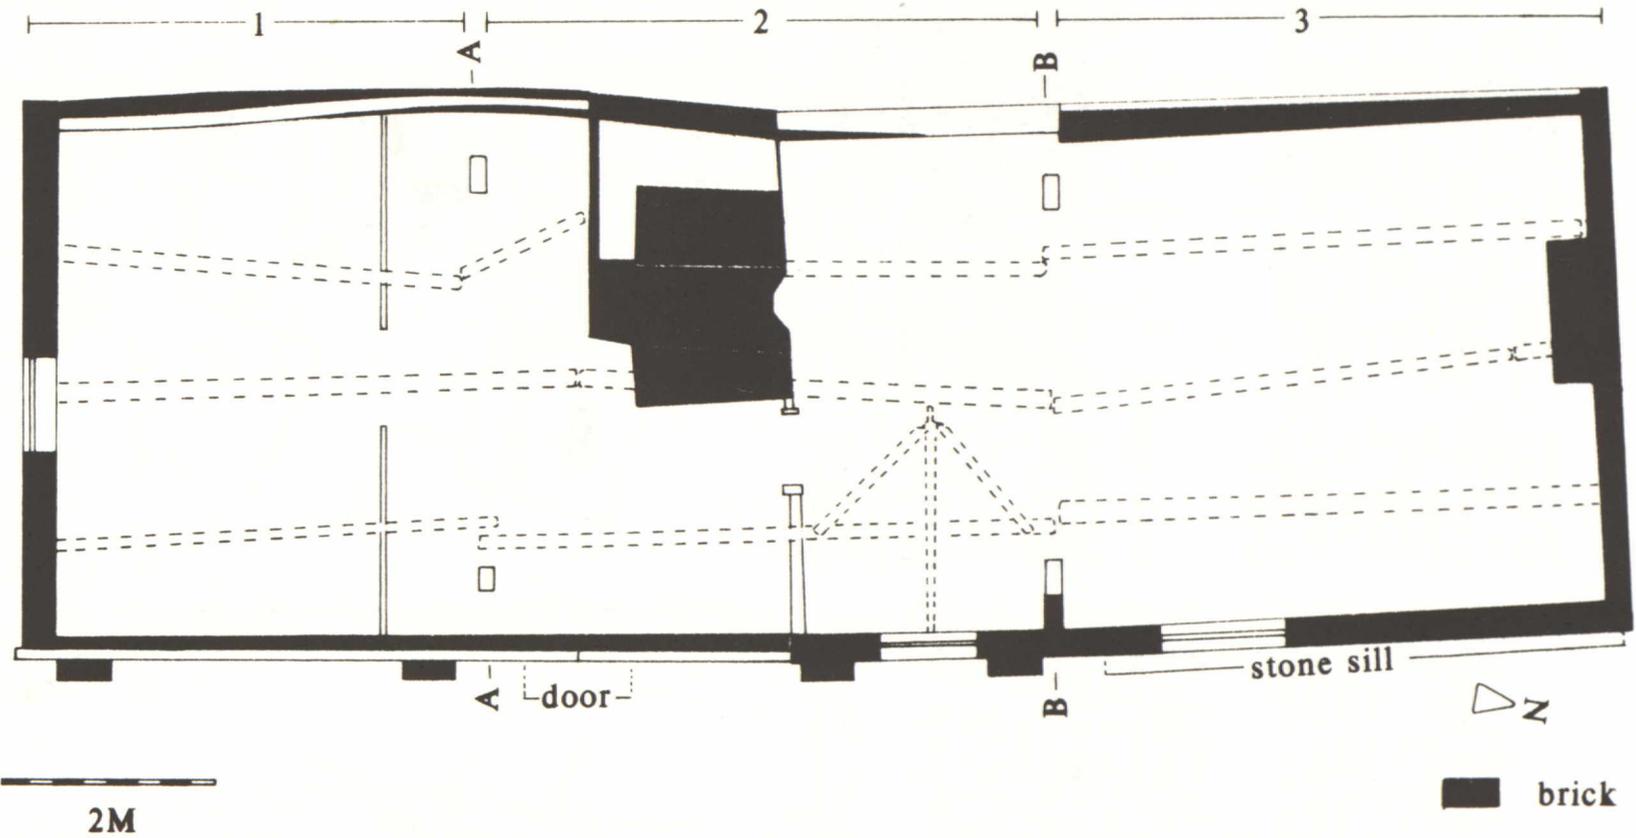
Figure 2. Plan of present building at first floor level

The Scotch Piper Inn is a two-storeyed, cruck-framed building consisting of three bays (Fig. 2). There is a central chimney stack and additional chimney at the north gable. The present entrance is by means of a doorway set almost immediately next to one of the cruck blades and on a line with the rear of the chimney stack. Evidence for an opposing doorway is not visible but may be obscured by a more recent extension to the rear of the building.

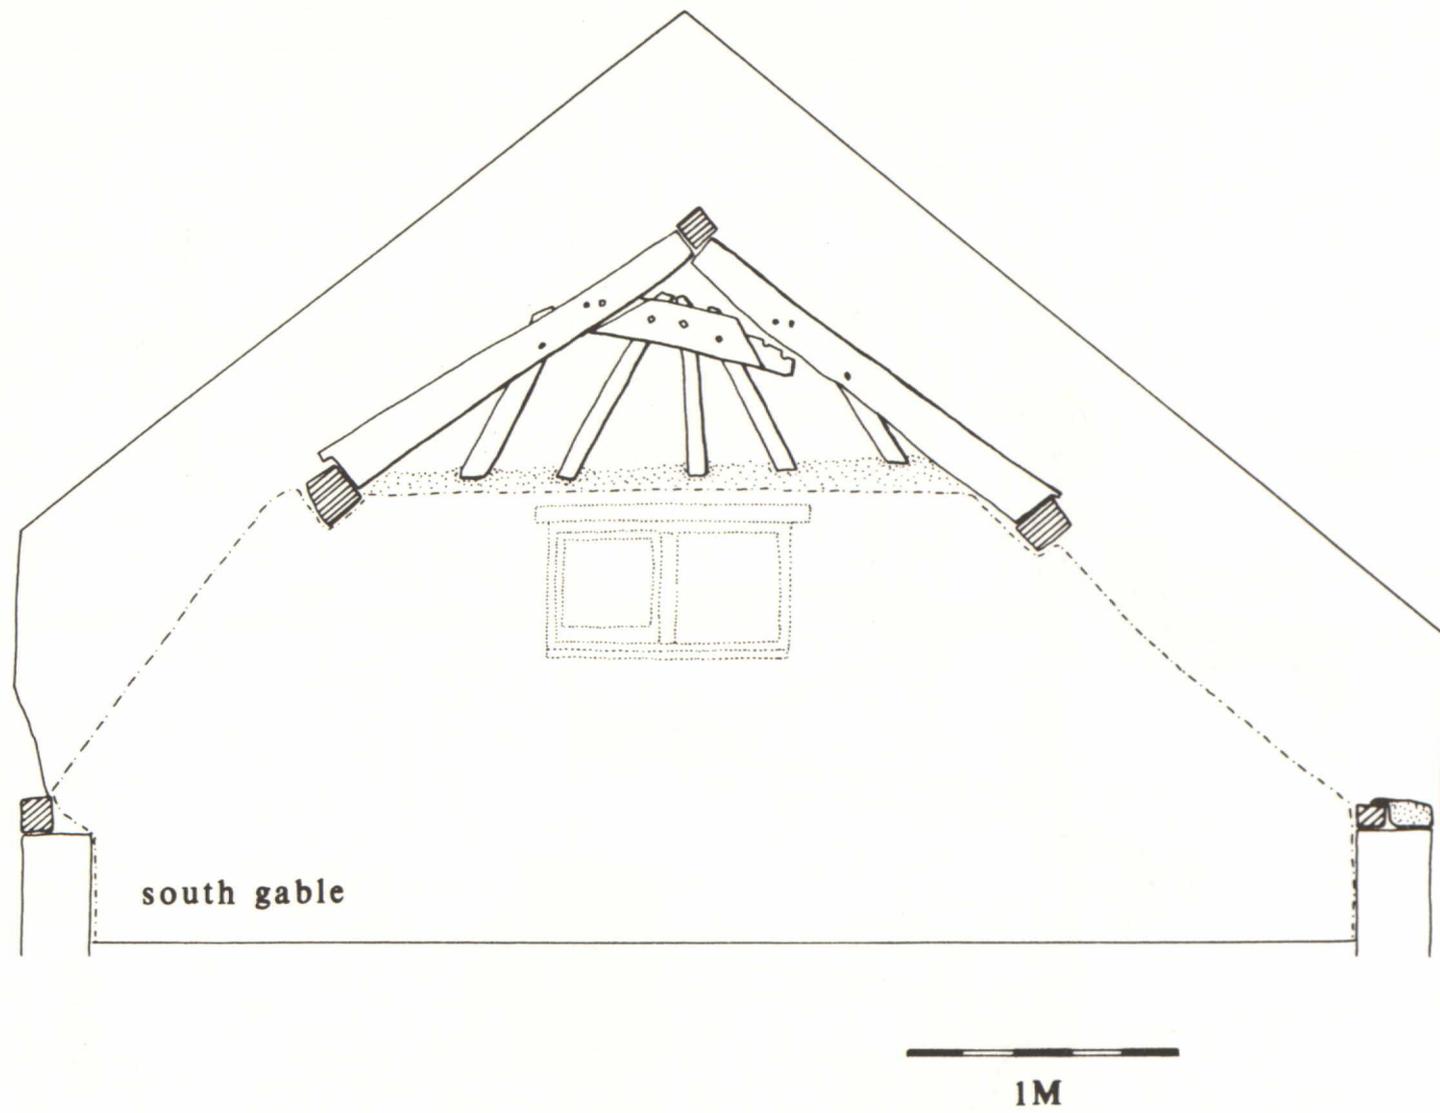
All external walls are of brick. Those of the west walls in the south (1) and centre (2) bays and the lower part of the south gable, together with part of the centre chimney stack, are probably the earliest brickwork in the building. The south gable has been extended upwards in modern brick (Fig. 3). Brickwork in the bay (3) and along the east elevation is relatively modern. It rests on a line of sandstone masonry, the blocks of which are large and rectangular in shape. They may well have been 'robbed' from Lydiat Hall or St. Catherine's Chapel. The west purlin has been introduced. From its straightness and the inclusion of three large mortices, it would appear to have been taken from a box-framed timber building, perhaps Lydiat Hall. A moulded joist in the ceiling of the ground floor may also have come from the Hall. Part of the centre bay and two buttresses on the east wall were rebuilt within the last eleven years. The upper part of the centre chimney stack is also modern.

At the south gable the original half-hip arrangement has been replaced. The ridge piece was extended and the brickwork build upwards. The struts of the half-hip were embedded in daub and encased in brick (Fig. 3).

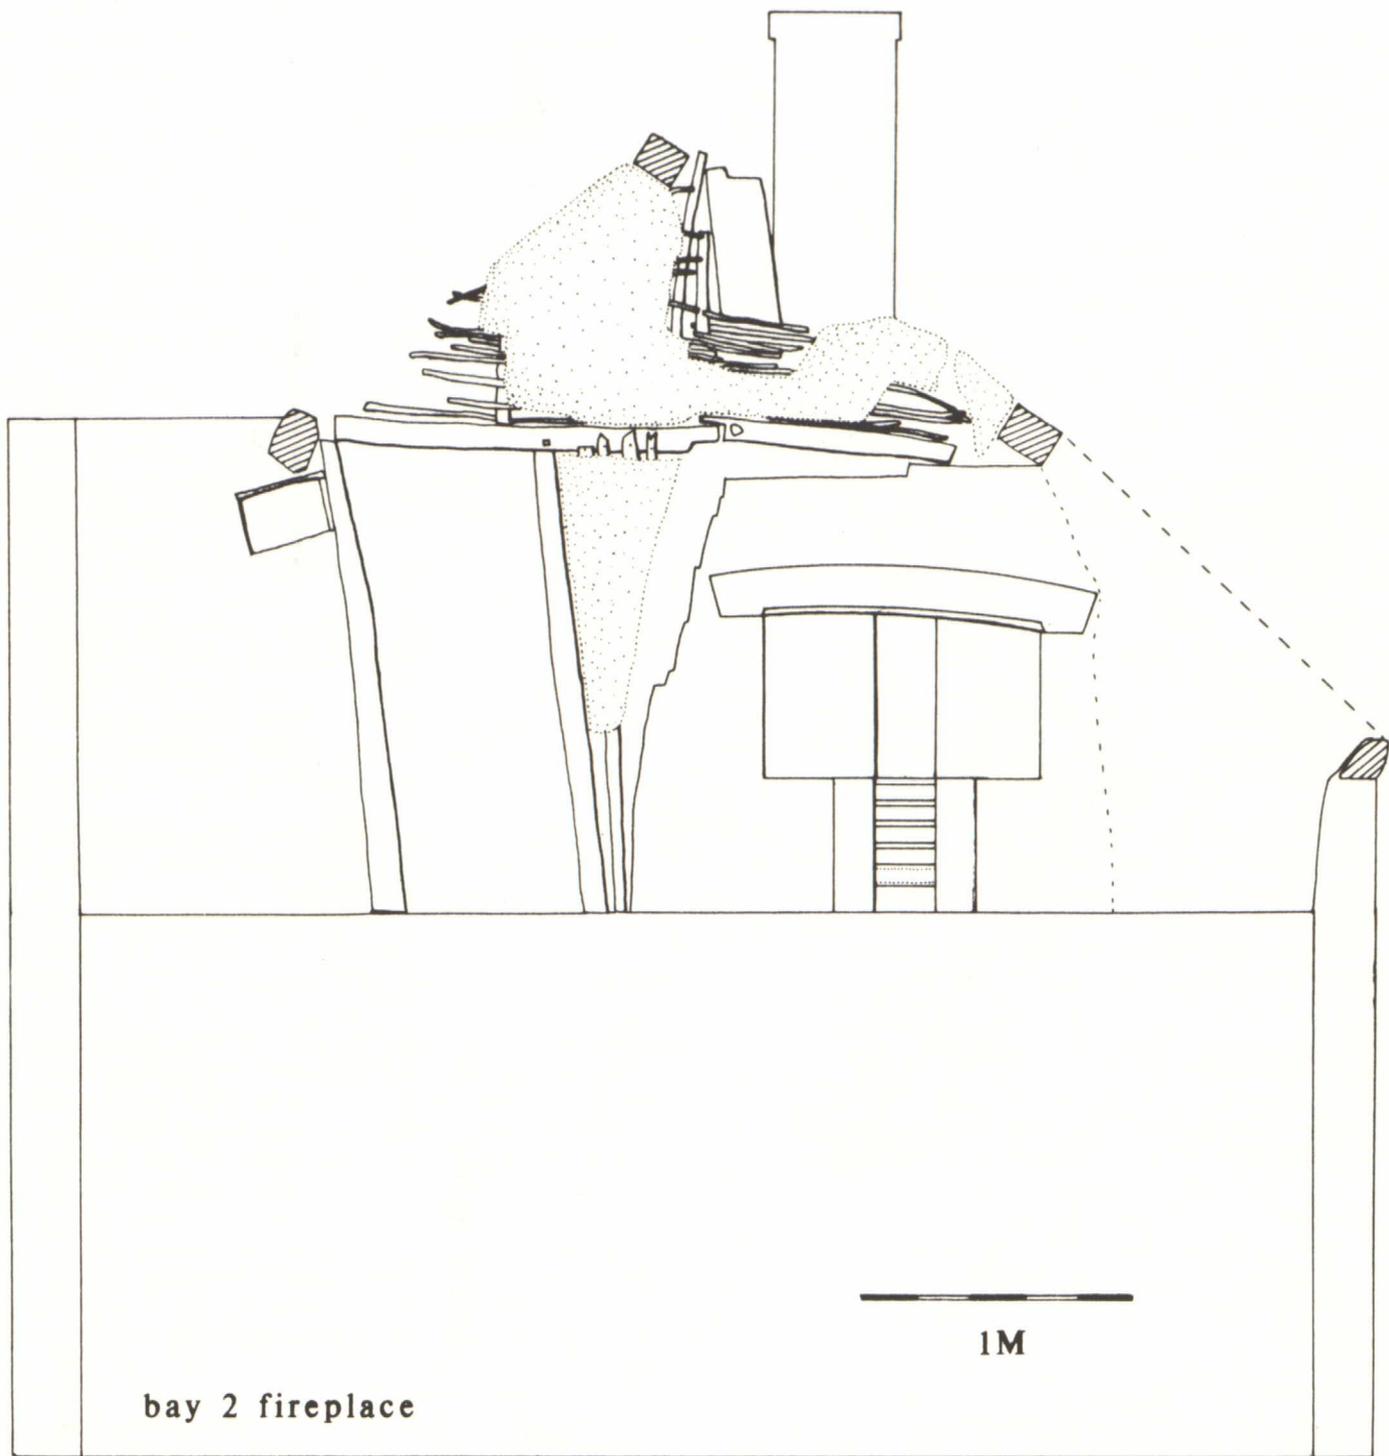
Figure 4. Fireplace elevation

Internal partitioning at the centre stack is of wattle and daub, overlaid with limewash (Fig. 4). There is a modern, plasterboard partition which separates the present (modern) staircase well from the cruck frame which stands between bays 1 and 2.

The centre stack is built of hand-made brick (Fig. 4). Fireplace openings occur at both sides of the stack at ground level. On the first floor there is a fireplace, with late 19th century grate, on the north side only. A smoke hood is formed of horizontal wattles and daub supported on an oak beam. Repairs to the stack are demonstrated by the use of daub, presumably to patch up holes in the original

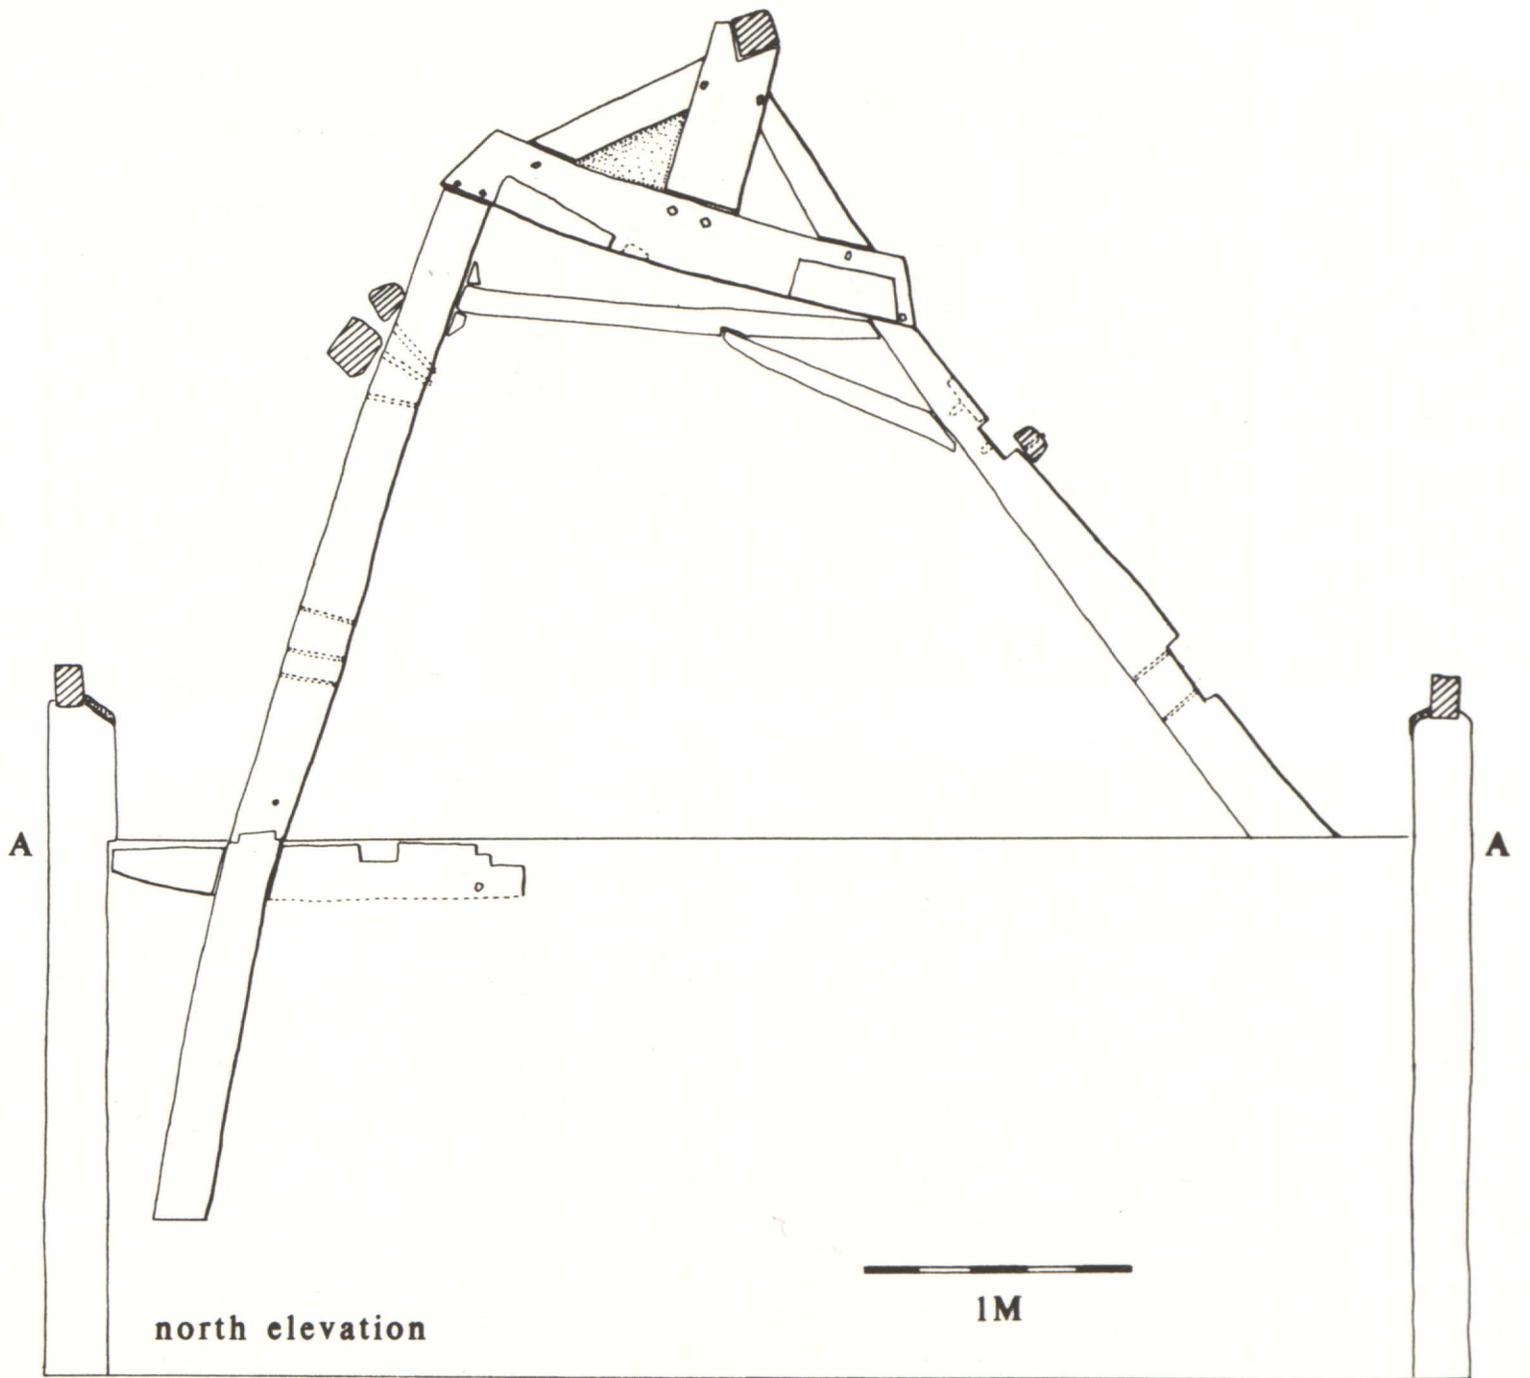
Figure 5. Frame A: North elevation

Frame A (Fig. 5) consists of a pair of oak blades with tie-beam (equivalent to present floor level and into which modern floor joists have been set). The tops of each blade are morticed into a collar above which there is a short king-post supported by straight-edged braces. The king-post is V-notched to take the ridge piece. King-post and braces are morticed into the collar and all joints are secured by wooden pegs.

The west blade runs down to ground level. It is cut to receive purlins, but the timbering is too badly worm-infested for details of the jointing to be clearly established. There is a pair of cuts to indicate the former existence of windbraces, the position of one also being shown on a cut into the purlin which runs into bay 1. The purlin which runs into bay 2 appears to be re-used from elsewhere.

The west blade has collapsed, probably due, at least in part, to poor selection of timber with a large knot immediately below the purlin position. As a result of the collapse the purlins have been forced out of their original housing. In order to re-establish an acceptable roof pitch the back of the cruck blade has been packed with thick layers of daub. The frame has been braced and battened to make it secure.

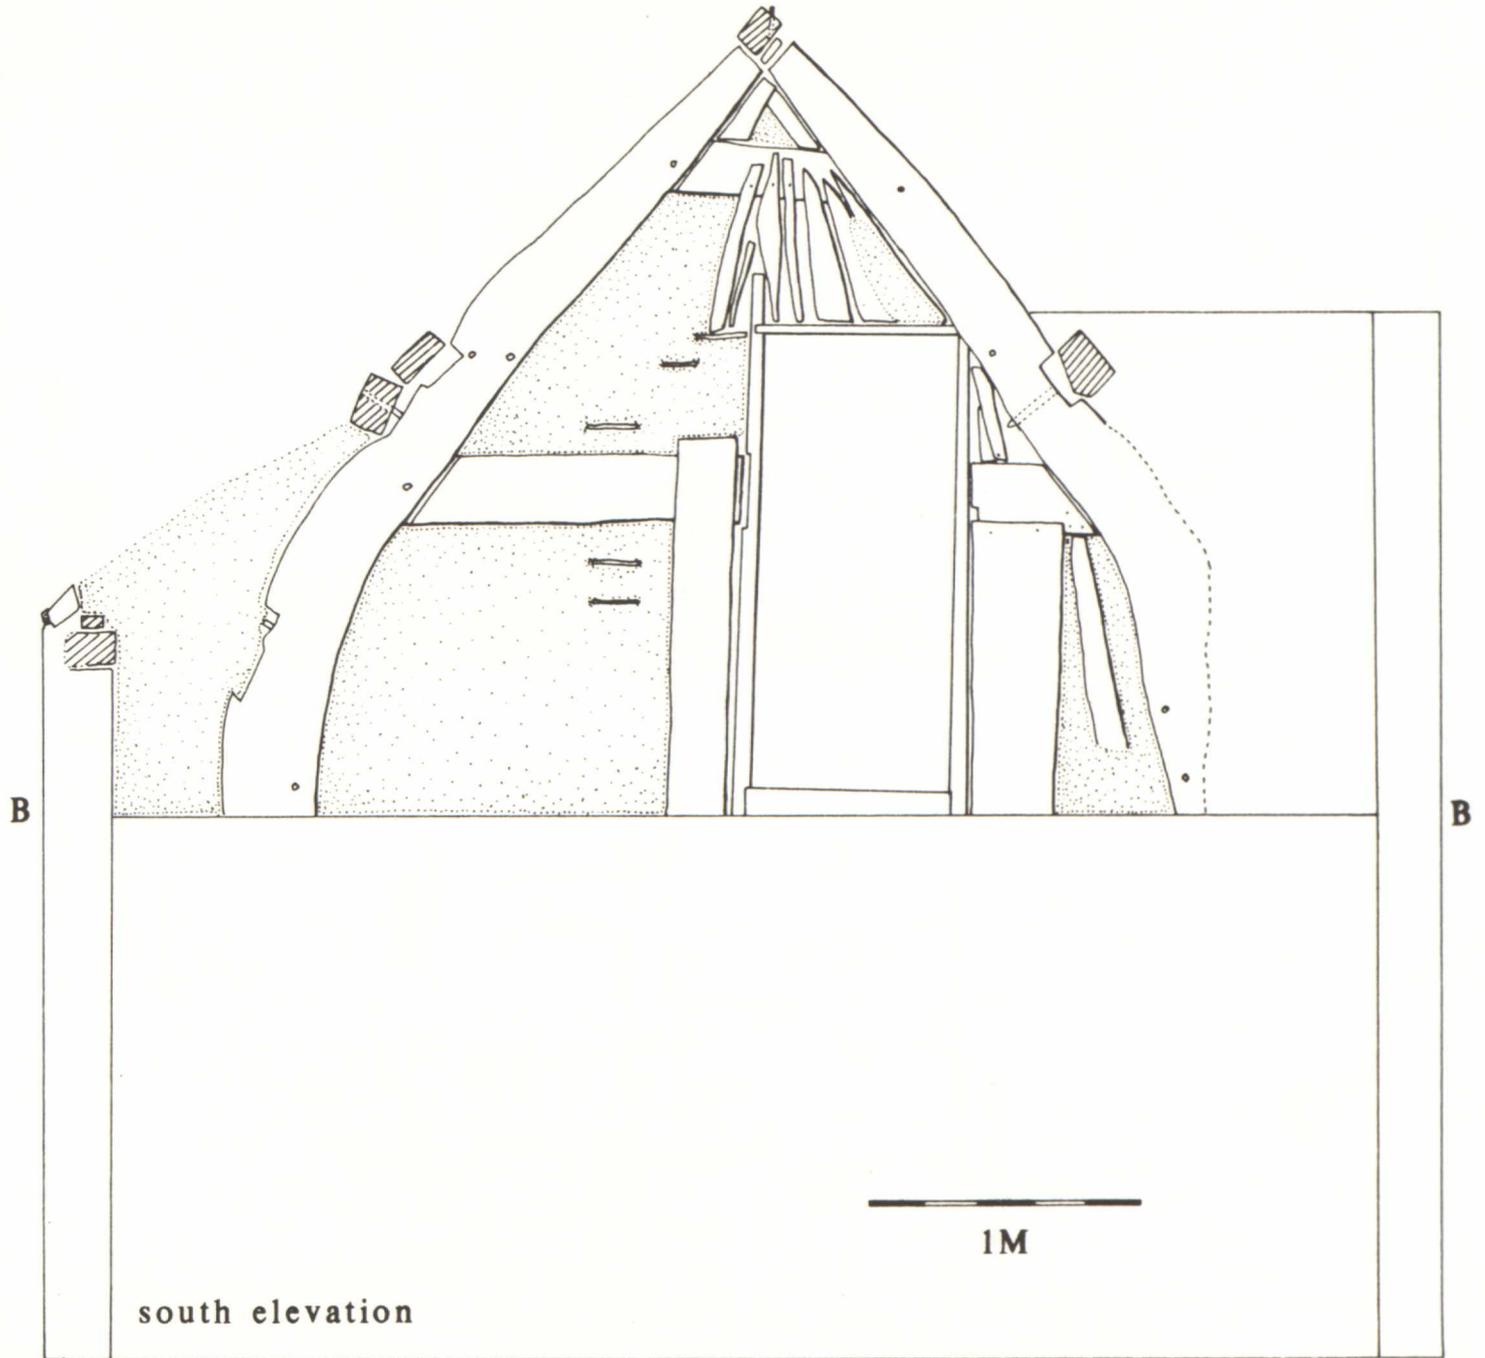
Figure 6. Frame B: South elevation

Frame B consists of a pair of matching oak blades (Fig. 6). The top of each blade is truncated to form an empty housing on which the ridge piece sits, jacked up by an additional, small timber block. The frame is cross-boarded but details of the jointing between boards and blades was obscured. Vertical staves are attached by iron nails to the upper boarding. Below, there is horizontal wattling and at the lowest level there is vertical planking. All is overlaid with daub to form a solid wall. A modern doorway has been punched through into the north bay (3).

The purlins butt, and are half-jointed to, the backs of each blade. Cuts for wind-braces are visible on the west blade, but modern repairs have obscured detail on the east blade.

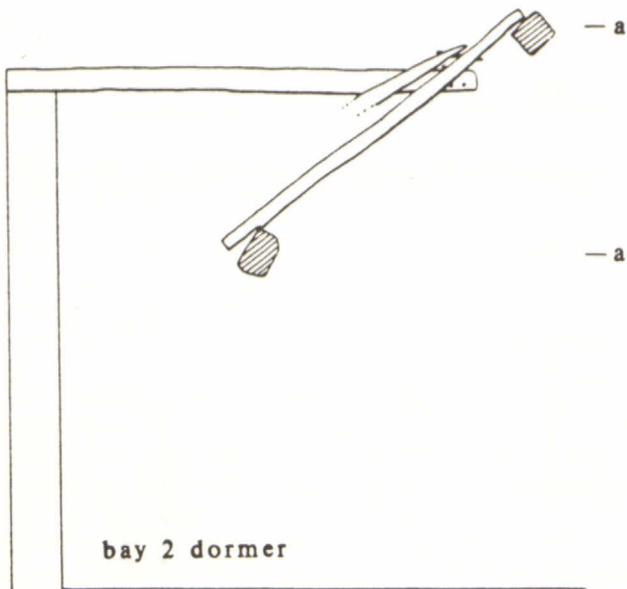
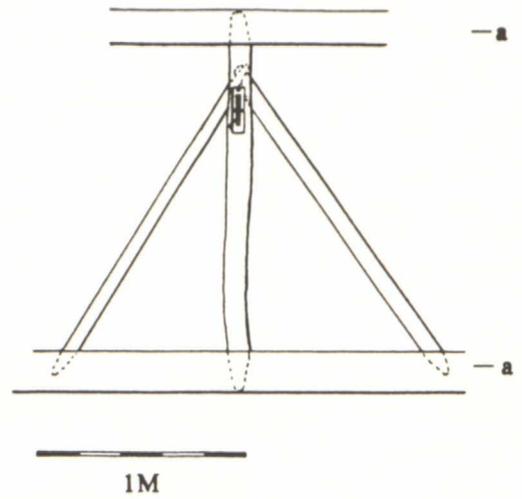
i

Original purlins survive only in bay 1 and the east purlin of bay 2. The evidence of frame B and the west blade of frame A suggests butted, halved jointing to be the usual method of attachment of purlins to frames (Fig. 7i and ii). Overlapping of the purlins on the east blade of frame A perhaps suggests that bay 2 was formed before bay 1.

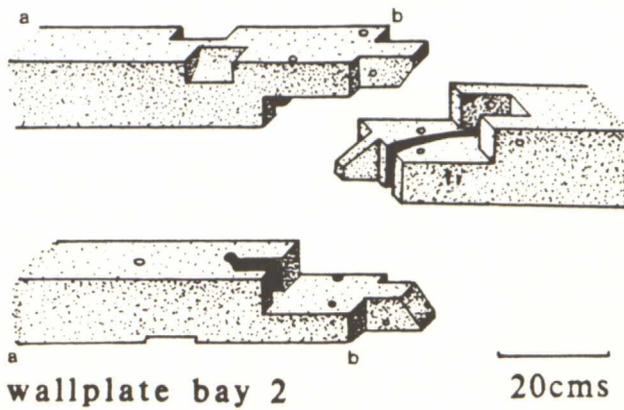
iii

A join in the wall-plate on the east side of bay 2 (a continuous length of timber which runs from bay 1) consists of an edge-halved scarf with open-ended mortices, pegged through with edge and face pegs (Fig. 7iii). Walling of vertical staves is suggested by circular slots cut into the under side of the wall-plate.

The wall-plate joint is not dissimilar to a type of joint (no. 263) recorded by Hewett (1980, 267). He notes that the latest dated example is from a barn in Essex of c. 1650. Dendrochronological analysis of the wall-plate in bay 1 (see below) has given a date of c. 1561 which falls well within Hewett's range.
