St Catherine's Chapel, Lydiate

In 1975 a group of students from Christ's College Archaeological Society visited St. Catherine's Chapel and decided to record as fully as possible the existing fabric of the Chapel, and to consider ways of conserving the remains. Accordingly a project was undertaken to construct a ground plan (Fig. 2) and measured drawings (Fig. 10). Few of the students, studying History, have had experience of this kind of work, and so the plans must be regarded as provisional. The techniques employed included the use of a plane table and simple clinometer.

Fig. 10. St Catherine's Chapel, Lydiate. Measured drawings, 1975.

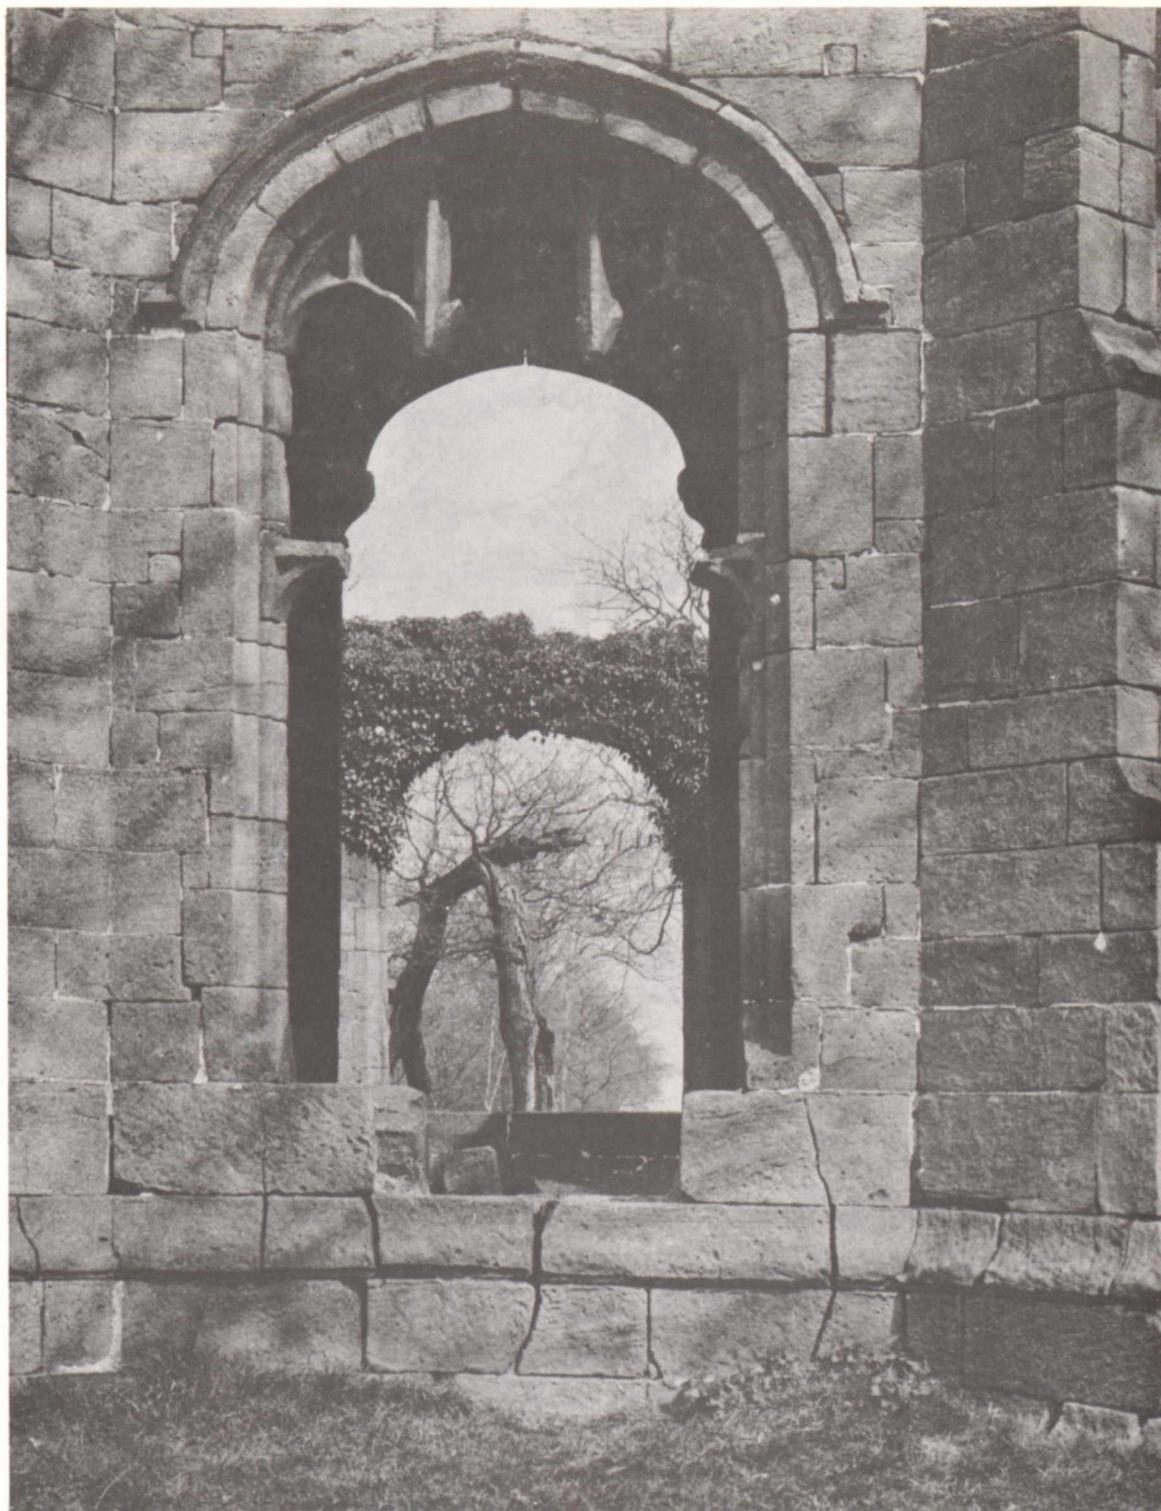
By the end of the century, however, these internal features were vanishing (Fig. 5). All the tower windows, together with those on the south wall, still carried dripstones with simple angled returns. According to Figs. 3, 5 and 6, the internal features of the great west window behind the altar had gone by the mid-nineteenth century. Roberts suggests (1848, 147) that the window originally carried five lights with tracery. According to Fig. 7, the east window supported a dripstone similar to those over the tower and south wall windows. By the mid-nineteenth century it seems clear that the finials on the north-east and south-east corners of the building had gone, to be followed by those on the south wall. By 1876, the battlements of the east wall were also vanishing. The stepped buttresses supporting the entire building were, however, still intact at the end of the nineteenth century (Fig. 8).

Fig. 5. West window of tower (from a photograph inserted in the copy of Gibson, 1876, in Ormskirk Public Library).

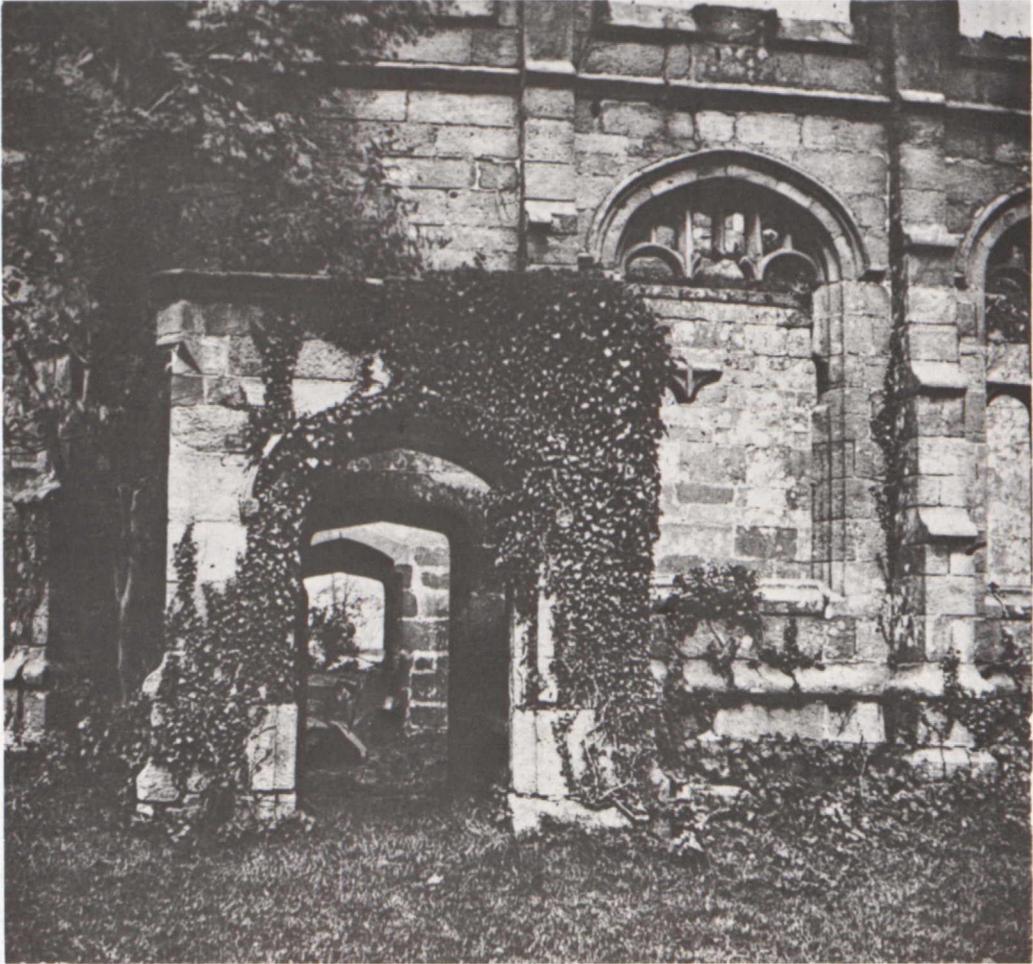
The porch on the south wall was perhaps the most interesting feature of the building. According to Roberts (1848, 147) and Gibson (1876, 174) the initials LI and CI could still be seen on the terminals of the dripstones above the outer doorway. By the end of the century it is clear that the four centre arches of the porch had collapsed (Fig. 9).

Fig. 9. St Catherine's Chapel, Lydiate, the porch. Gibson, 1876, Frontispiece)

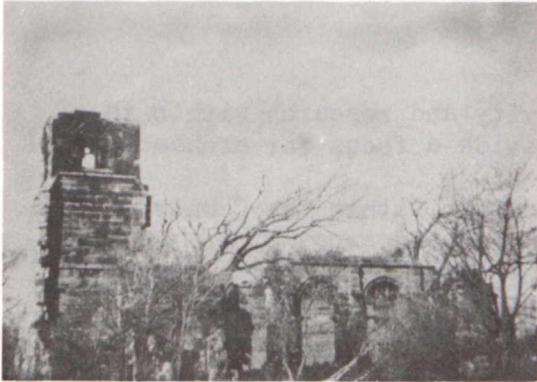
11a. North Wall..

The north wall, in the absence of windows, seems the most stable, possibly because the buttresses there have suffered less than the others from stone robbing. Nevertheless, a large crack apparent on the interior of the wall runs from top to bottom and constitutes an obvious hazard. The unusual bonding of the masonry together with numerous putlog holes can be most easily discerned here. The doorway at the west end of the north wall, though less ruined than that on the south wall, is almost blocked by fallen masonry. It is rebated and has a bolt hole.

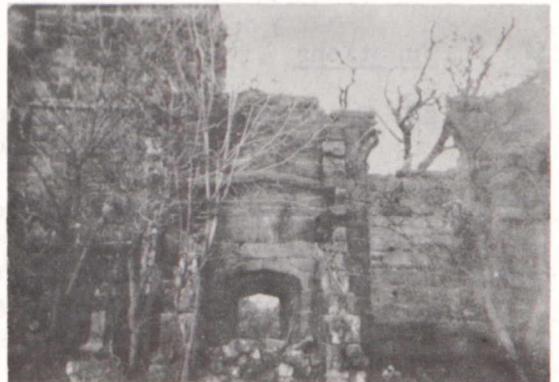
11b. Porch, west end of south wall.

The porch at the west end of the south wall is extensively ruined. A heap of masonry (Fig. 11b) partially blocks the entrance. There is no apparent evidence of the stones bearing the initials of the founders, but it is possible that these may still be recovered. The doorway is rebated and has a bolt hole.

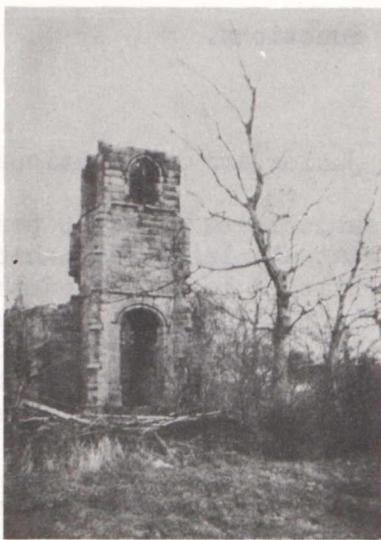
11c. Tower, west wall.

The tower is built in three stages. The base is pierced in the west wall by a large window, the tracery of which is now completely gone. The window arch is loosening (Fig. 11c), thus weakening the whole fabric of the tower. The window sill is reduced to rubble at ground level, allowing comparatively easy access to the interior. The stepped diagonal buttresses supporting the four corners of the tower show evidence of stone robbing. No trace of the finials crowning these buttresses remains. The small belfry still surmounts the second string course of the tower. Of the four windows, those on the north and west sides have lost their tracery, while all sign of the battlements and finials above these has gone. Only a fragment of iron indicates Blundell's repair. The masonry at the top of the tower is loose and dangerous. The archway leading from the tower into the interior is weakening, rendering the condition of the tower still more hazardous.

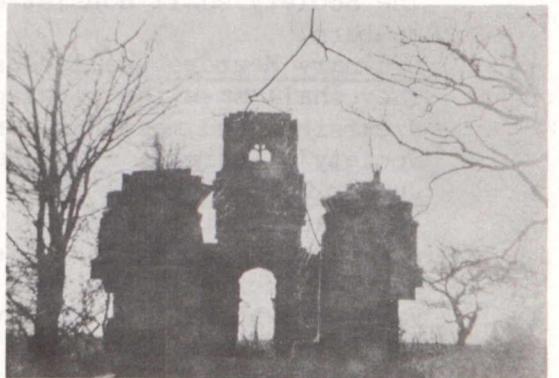
11d. East wall.

The east wall of the chapel shows the greatest dilapidation. The arch of the big window has collapsed. The sill is ruined and access across the rubble into the interior is comparatively easy. The walls, unsupported by the robbed buttresses show signs of bulging outwards. (Fig. 11d).
