JOURNAL OF THE MERSEYSIDE

ARCHAEOLOGICAL SOCIETY

VOLUME 8 (FOR 1988-89)

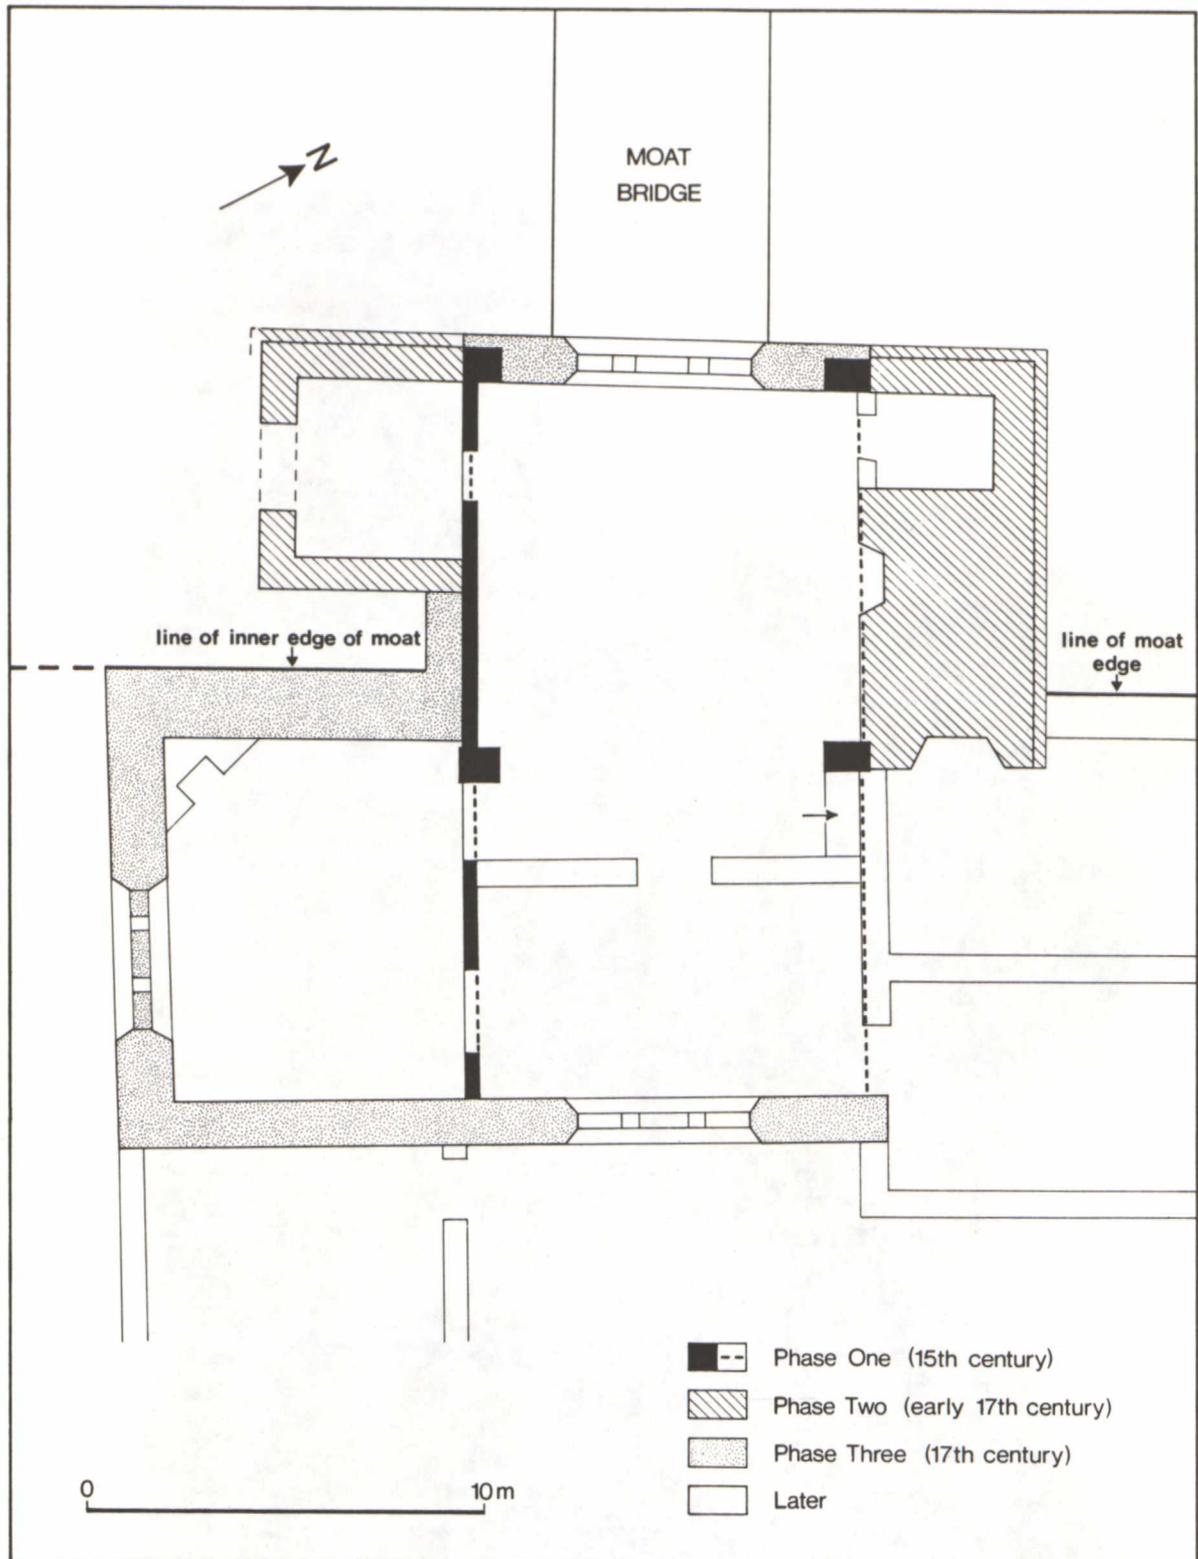
Figure 3: The gatehouse: an interpretation of structural phases (simplified; based on plans by W. G. Prosser, Royal Commission on Historical Monuments (England)).

The projections on each side of the gateway were new constructions, in English-bond brickwork, with small circular stone portholes (Plates II and III). They were designed to appear symmetrical from the west, but were in fact unequal in size. Each contained a chamber at ground and first floor levels, but those of the north were smaller than the southern ones, and they screened a chimney stack. The stack served a fireplace in the room above the western half of the gate passage, which had 'John Ireland 1608' carved upon its mantelpiece (Rylands 1893, 24). The brick projections were founded upon offset, chamfered plinths of sandstone.

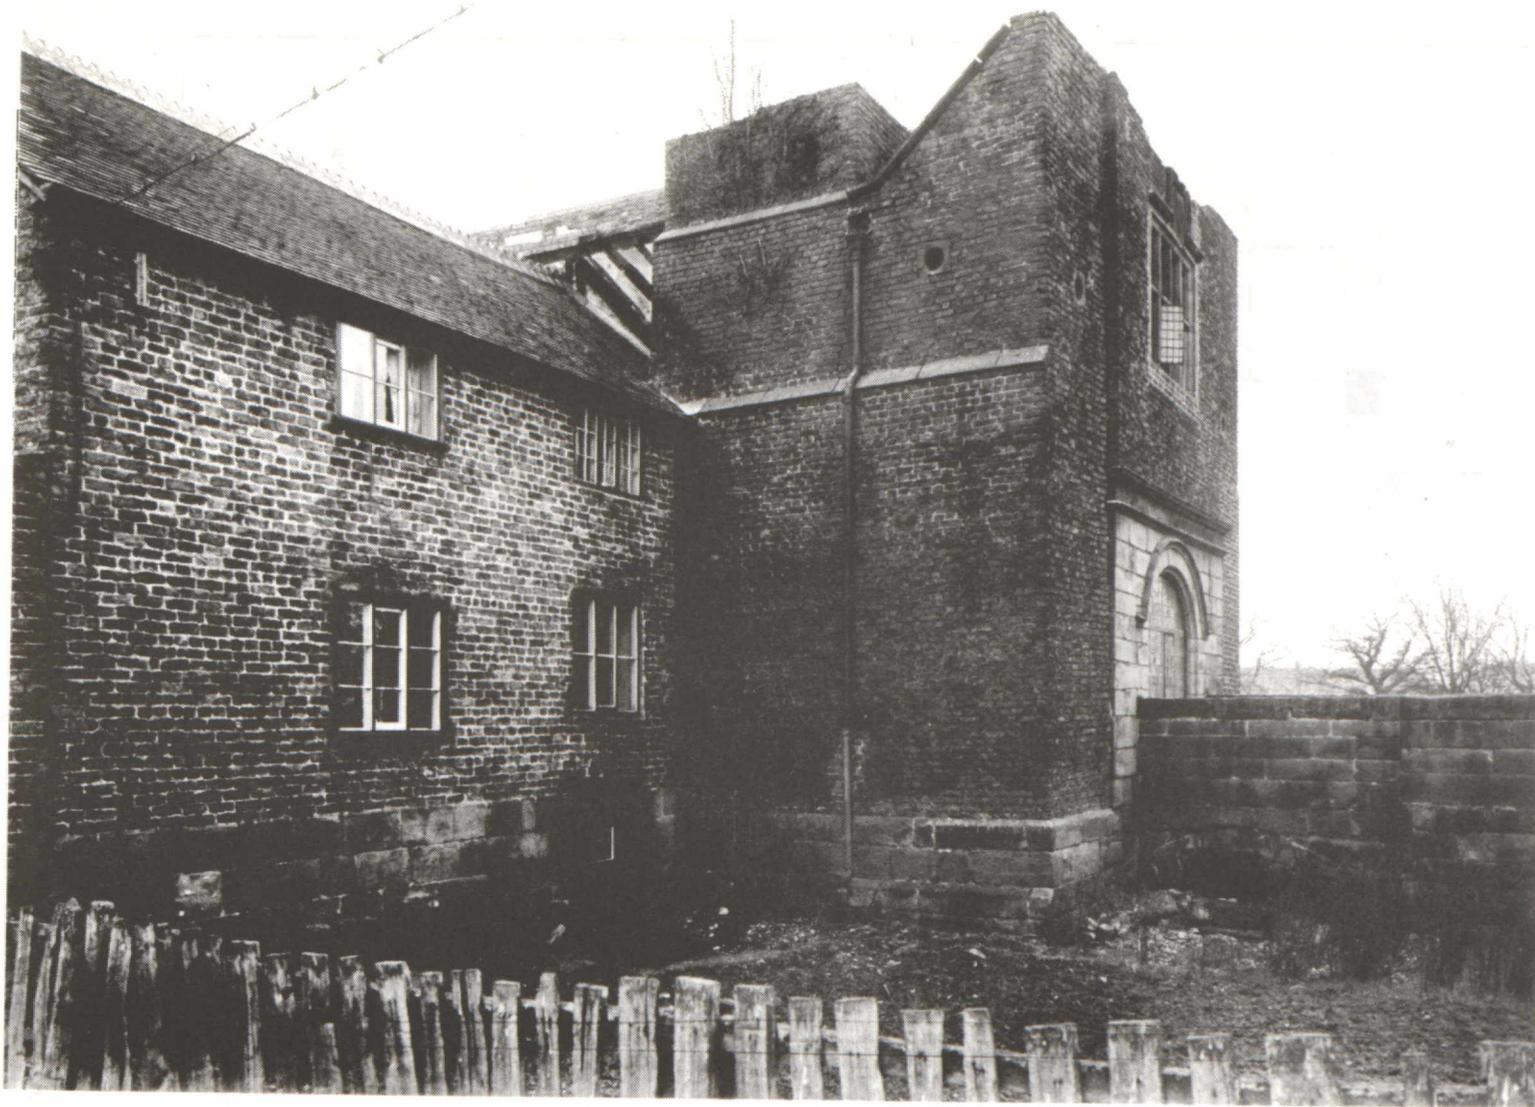
Plate II: The gatehouse from the north-west in 1960, showing the stone plinth of the brick projections (RCHM(E)).

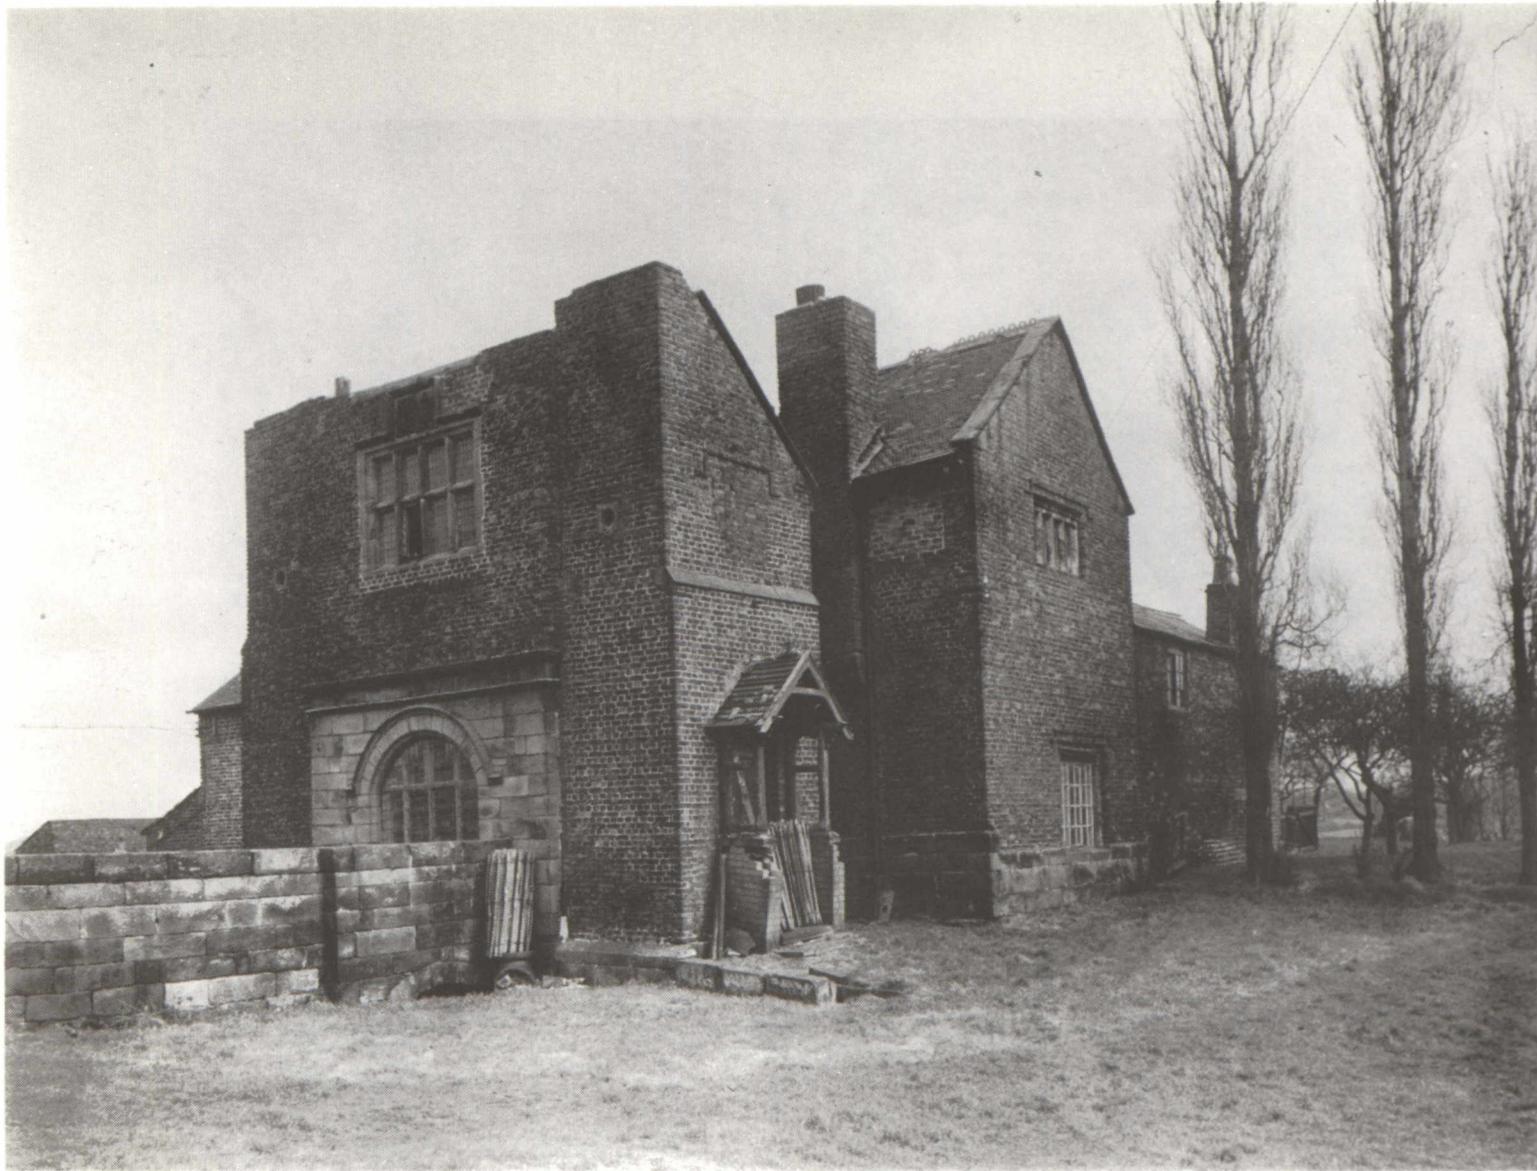
Plate III: The gatehouse from the south-east in 1960 (RCHM(E)).

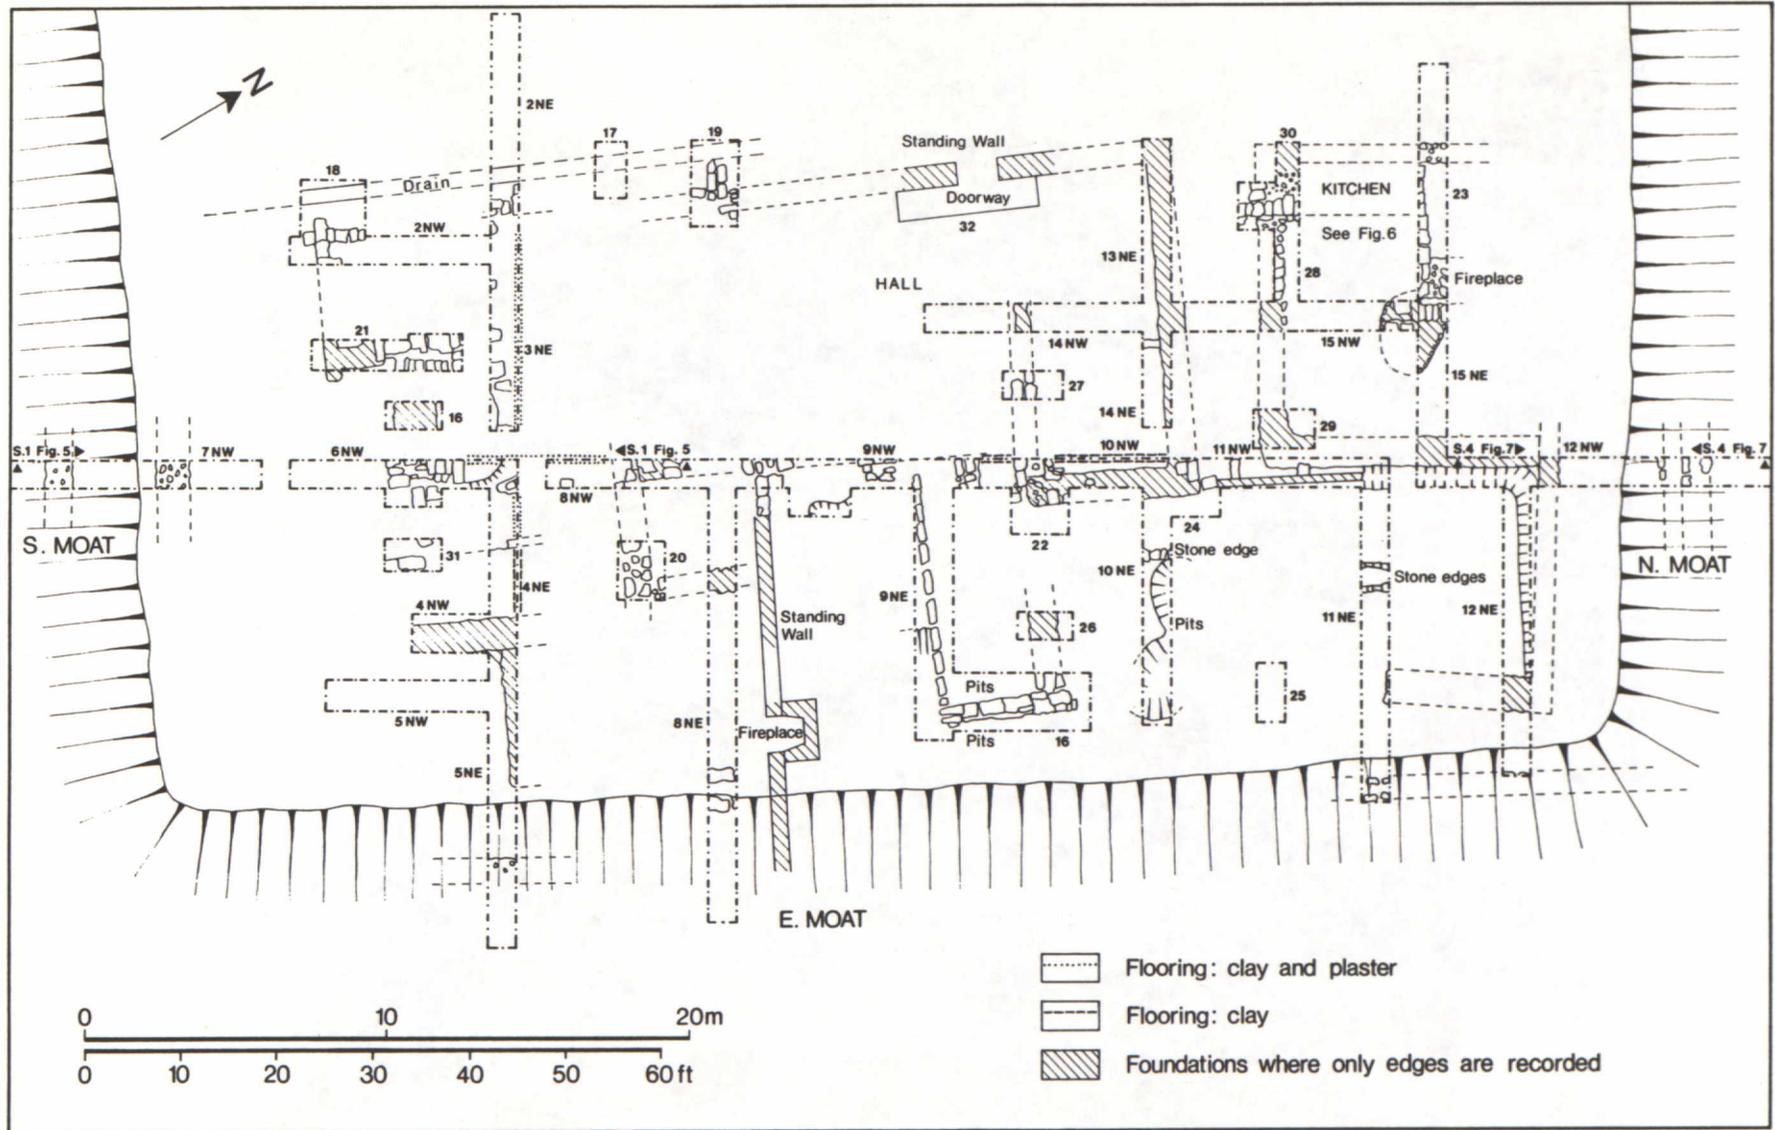
Figure 4: The excavations: general plan of trenches and structures in the eastern half of the moated island.

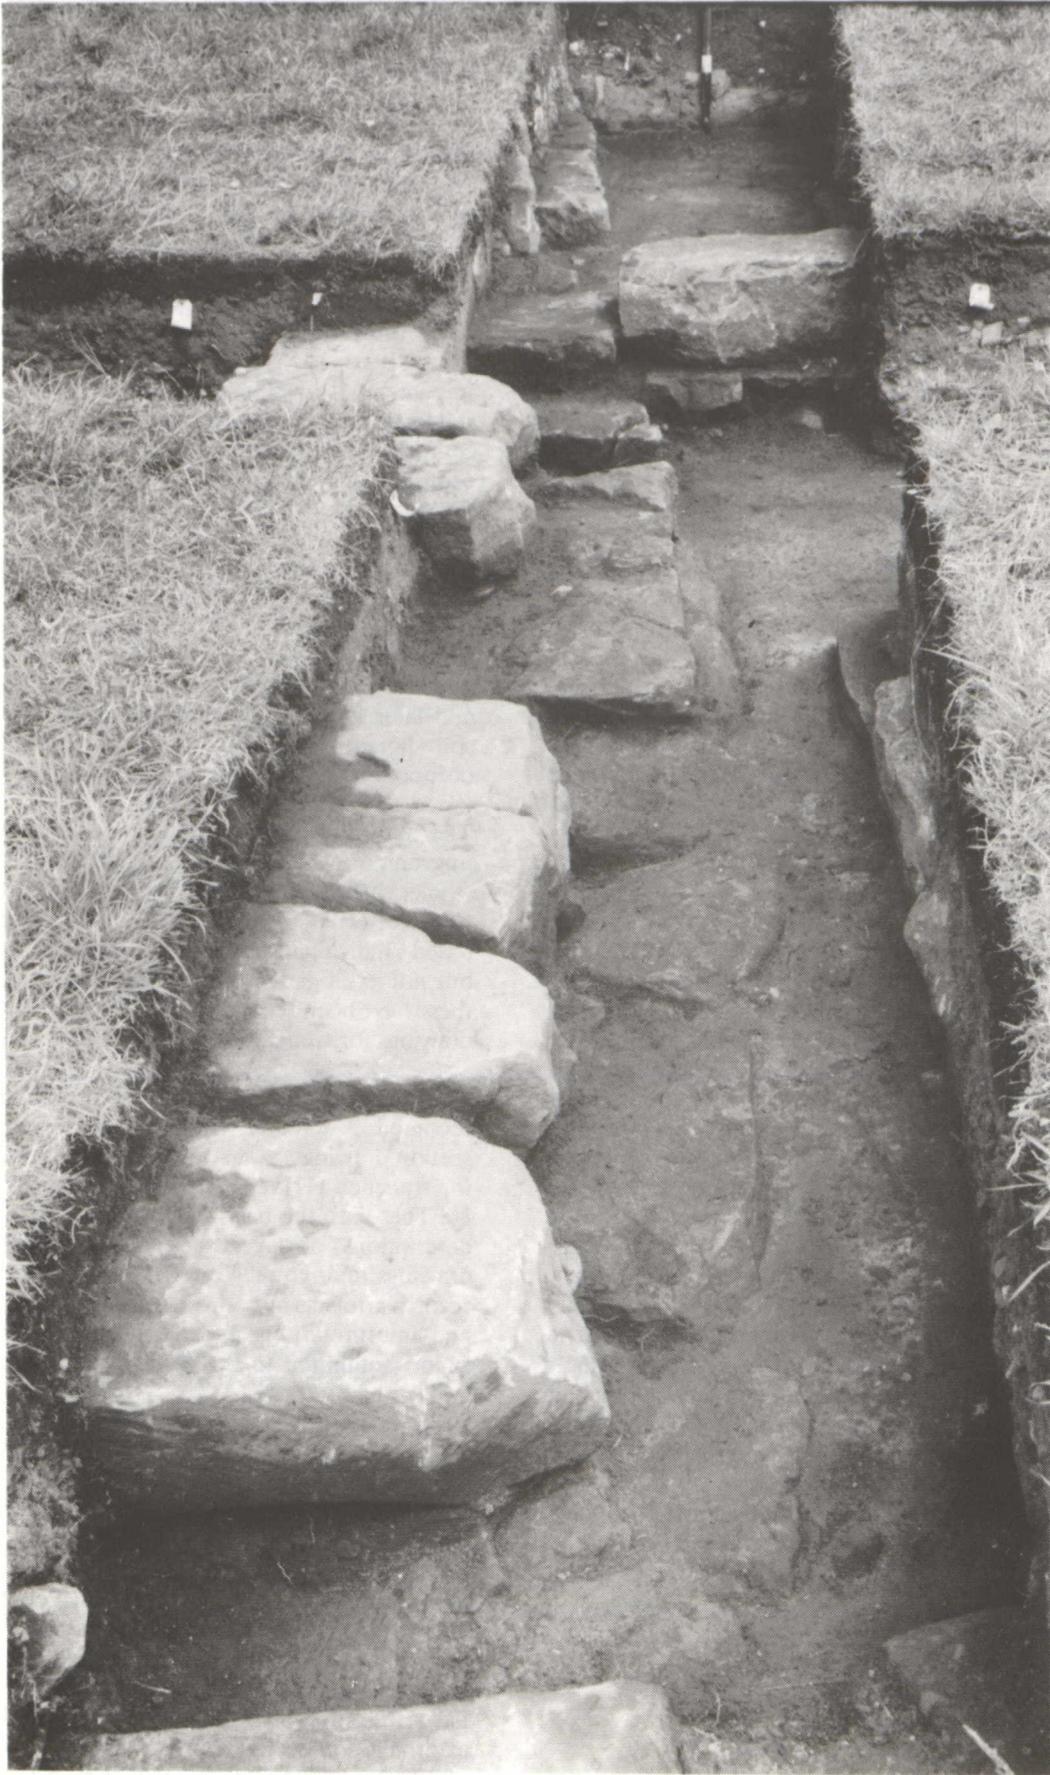
Plate VI: The foundation of the north wall of the hall block, viewed from the north.

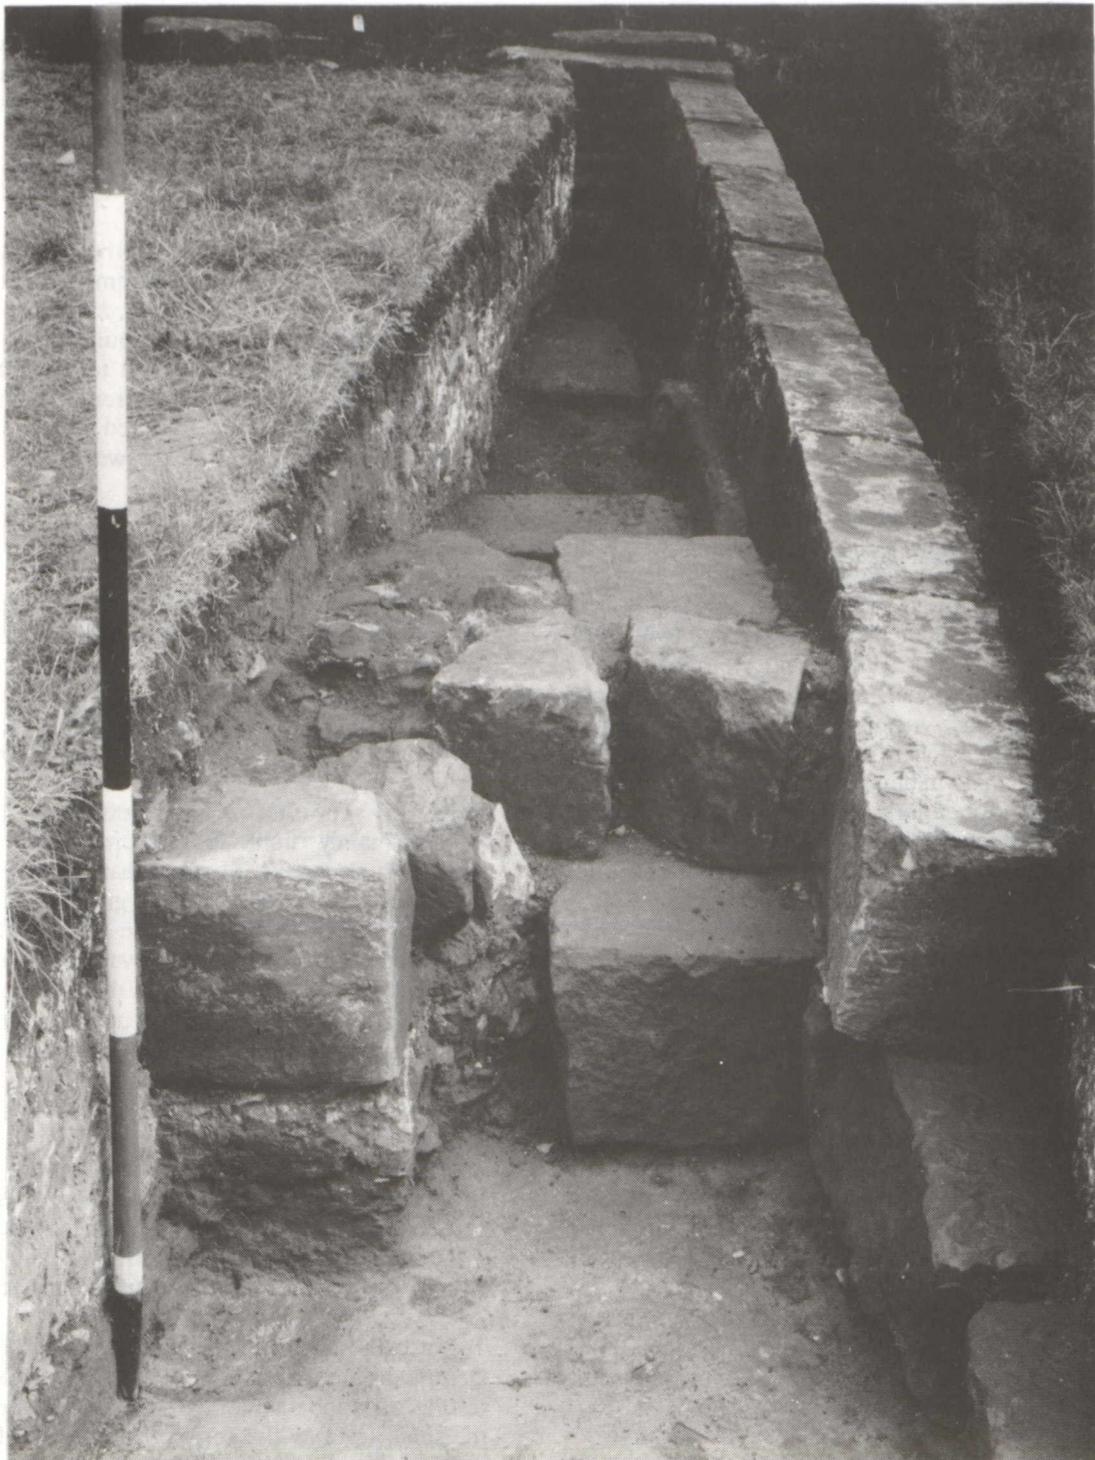
Plate VII: The stone sill of a timber wall, south wall of the 17th century extension east of the hall screens passage, viewed from the west.

Another 17th century addition extended east through trenches 9NE, 16, 22 and 26. This comprised, on the south side, another single line of sandstone ashlar blocks with a level top (Plate VII), set on a wider foundation and presumably a sill for timbering. Only two of the original blocks remained on the east end foundation, which incorporated a piece of medieval architectural stonework: a corbel which had probably supported a roof truss of the medieval hall, with an attached springer for an arch (Plate VIII). A third block had been used to increase the width of the sill; if it was the sole survivor of another line, it may indicate the replacement of a timber wall by brick. This room was built over an area containing a number of pits. Some of them, at least, must have been filled at or before the time this structure was erected.

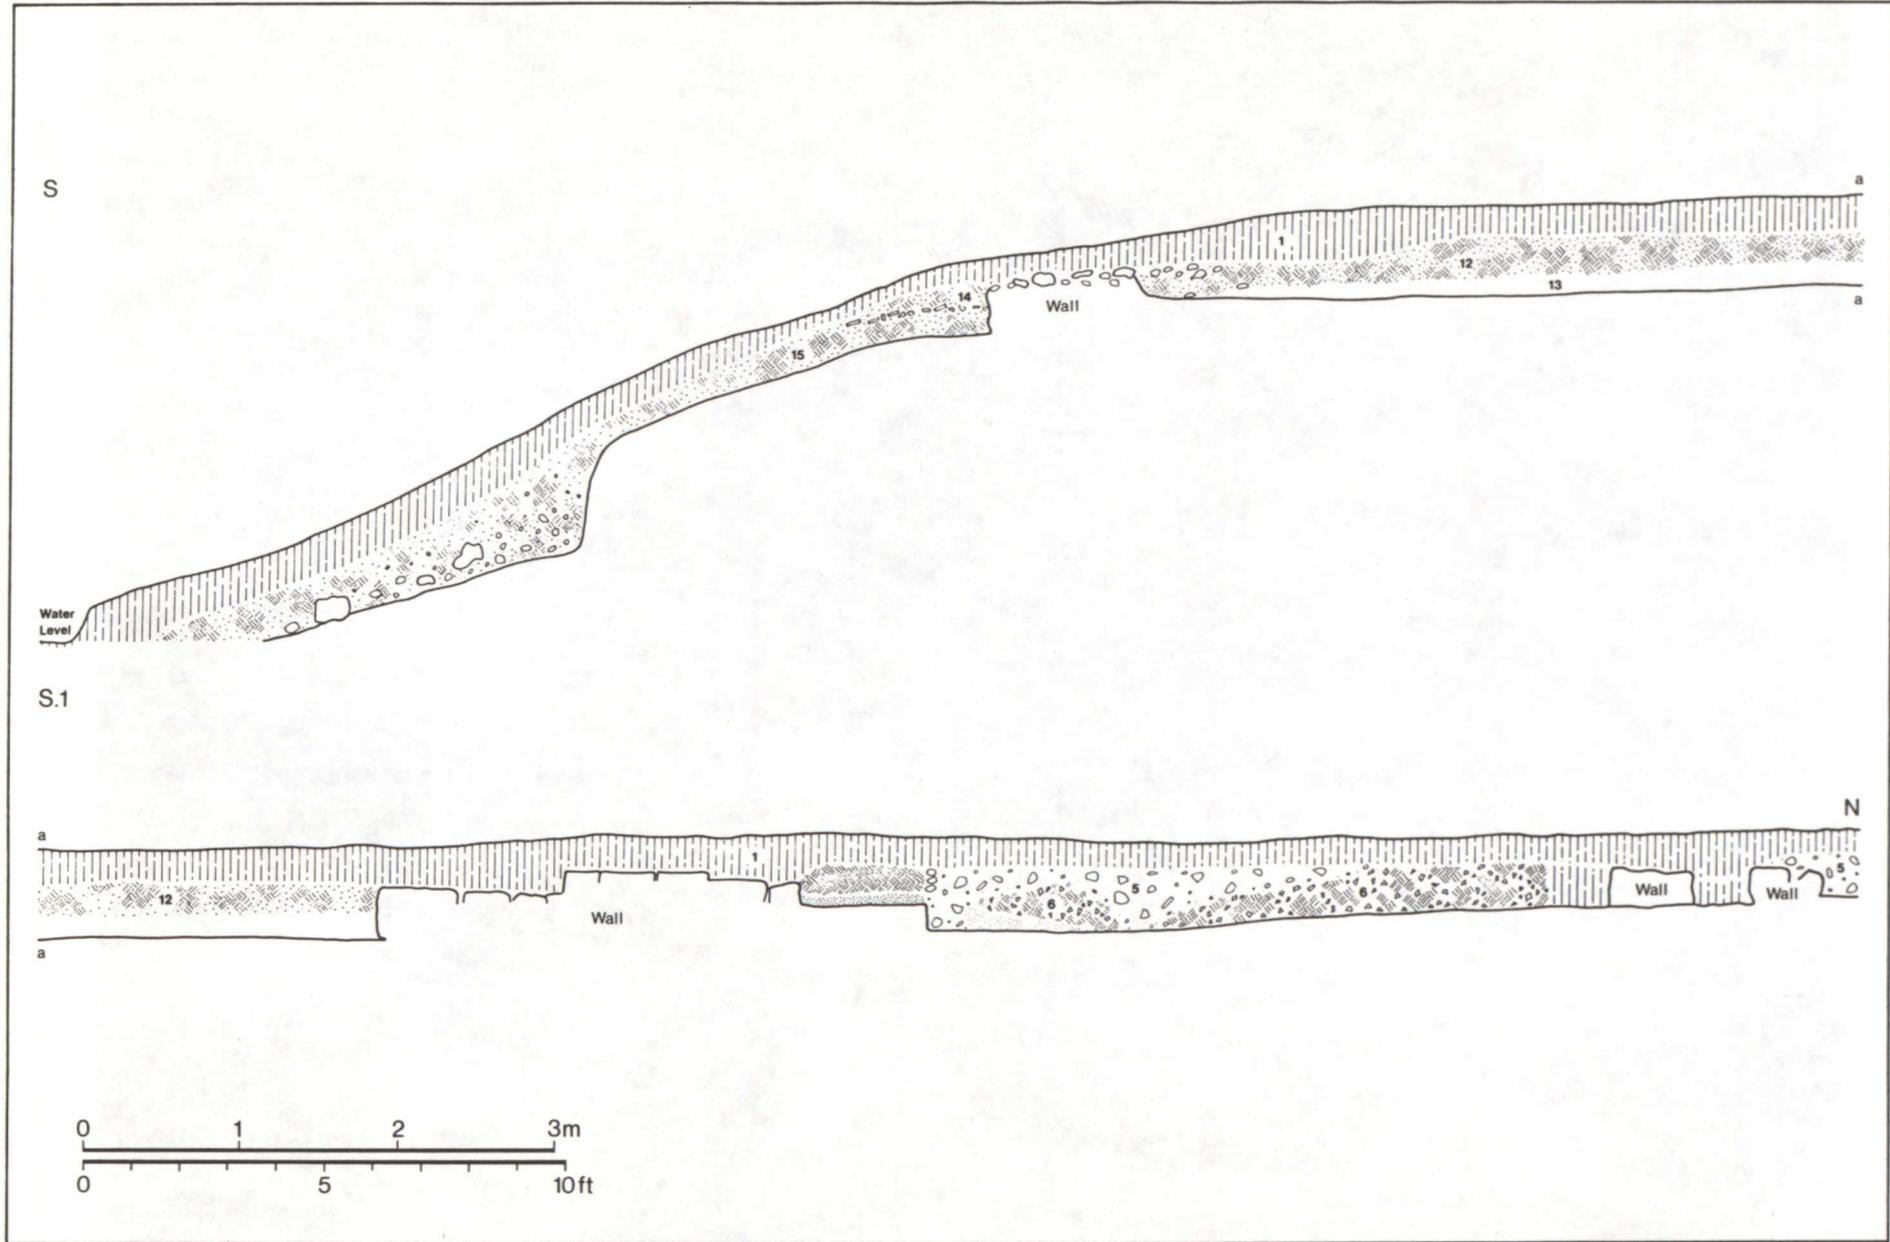
Figure 5: The excavations, section S1 through hall block and south moat. Numbered layers are: topsoil (1); rubble (5); clay and plaster (6); sandy buff soil (12, 15); old ground surface (13); sandy red soil (14).

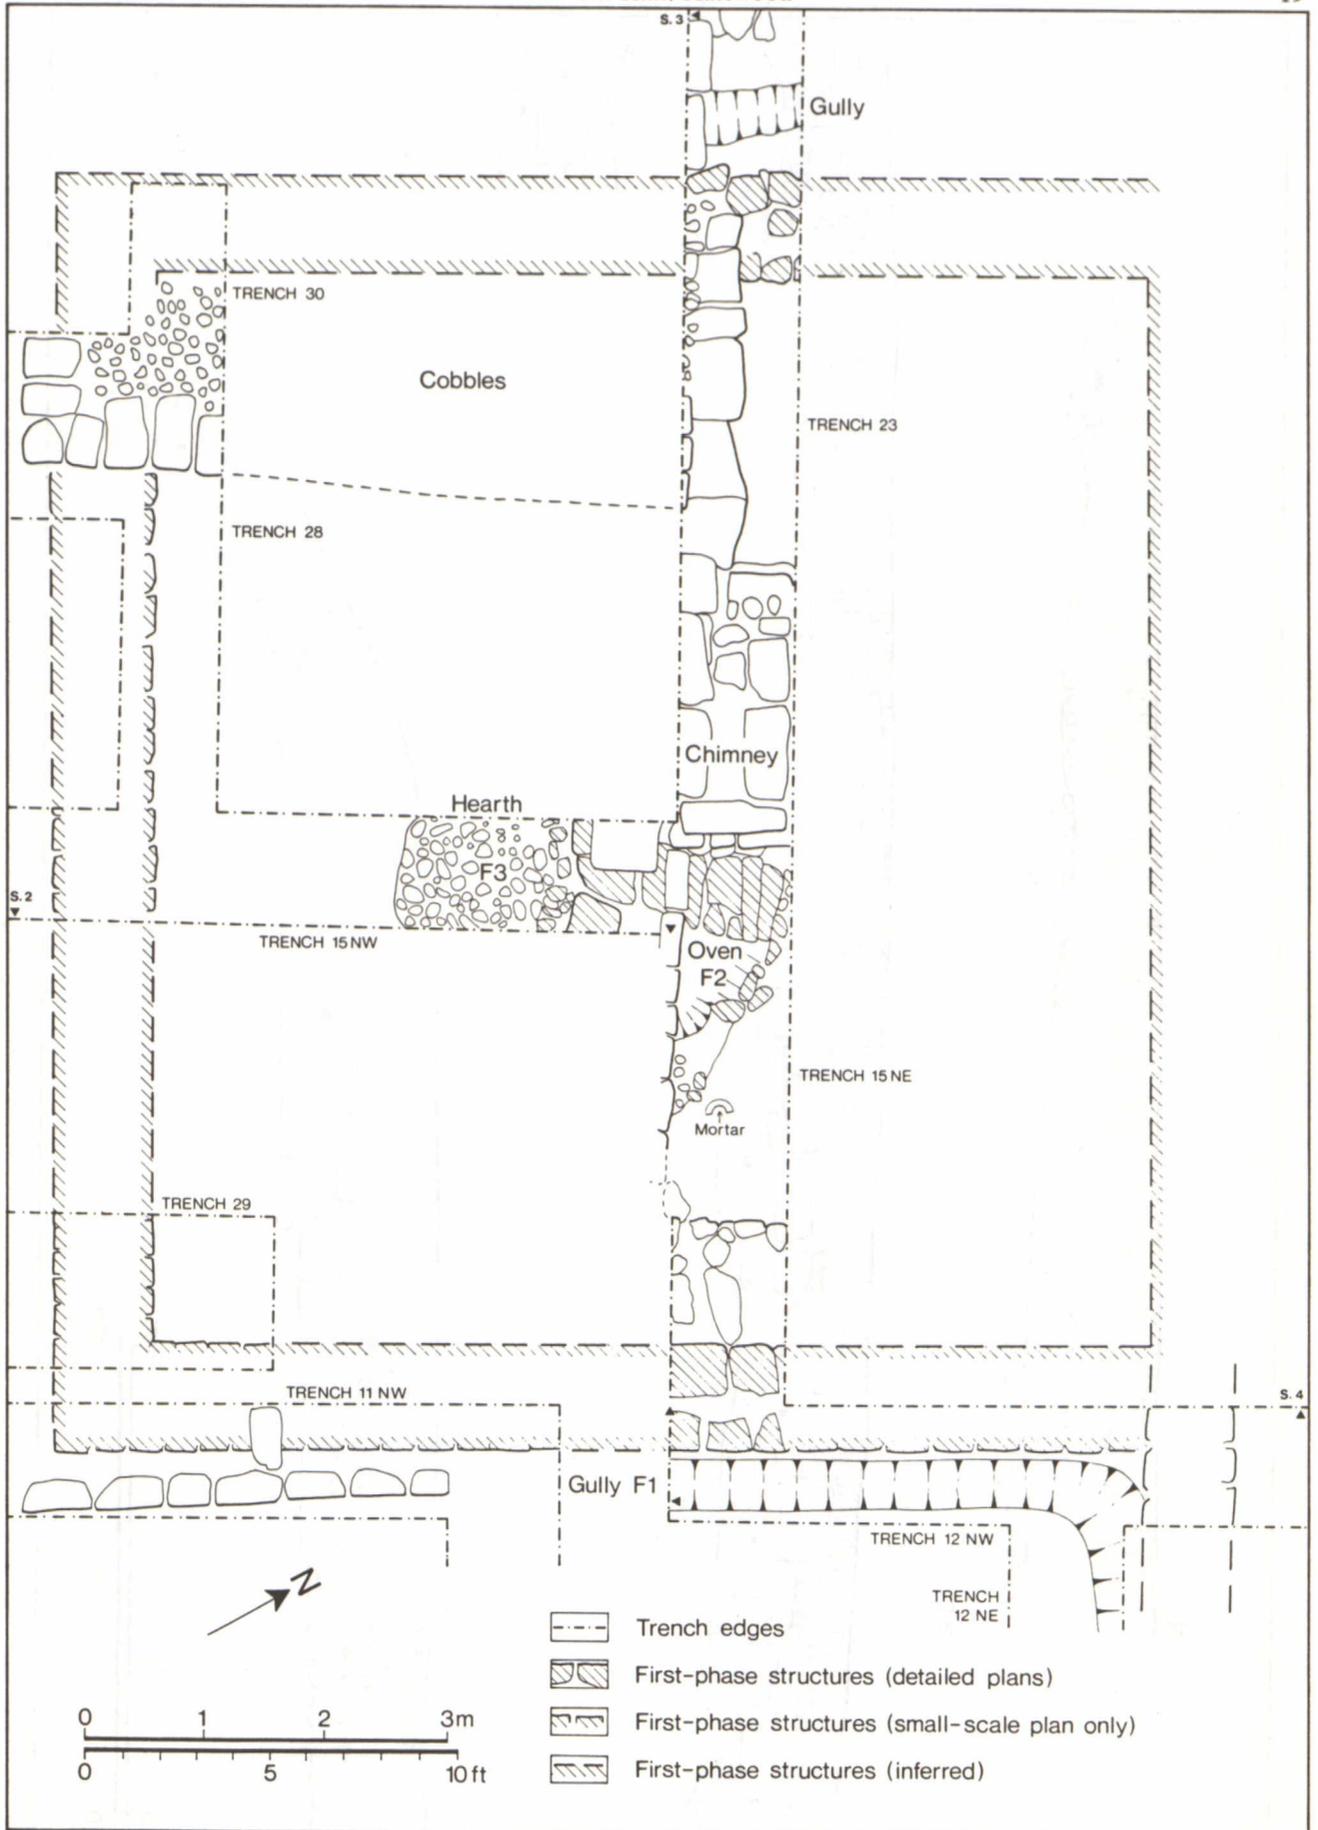
Figure 6: The excavations, plan of kitchen structures.

Phase I. The first phase is defined by the primary walling (mainly rubble foundations) on the west, east and south sides (Fig. 6). Immediately outside the first two of these walls were drainage gullies. The north wall was not located, because the siting of caravans prevented trenching in the relevant area. Its position can, however, be estimated from the evidence of trench 12NW (Fig. 7, S4), where the north end of the east wall presumably marks the point of return westwards, beneath a secondary wall. The floor base of the first phase was numbered layer 12 in trench 15NE. It comprised buff-brown silt and clay, with patches of sand. It may have been either the disturbed old ground surface, or a deposited levelling layer. The latter is perhaps the more likely, since there was no record of a foundation trench for the east wall cut through it: layer 12 appears to run right up to the facing stones.

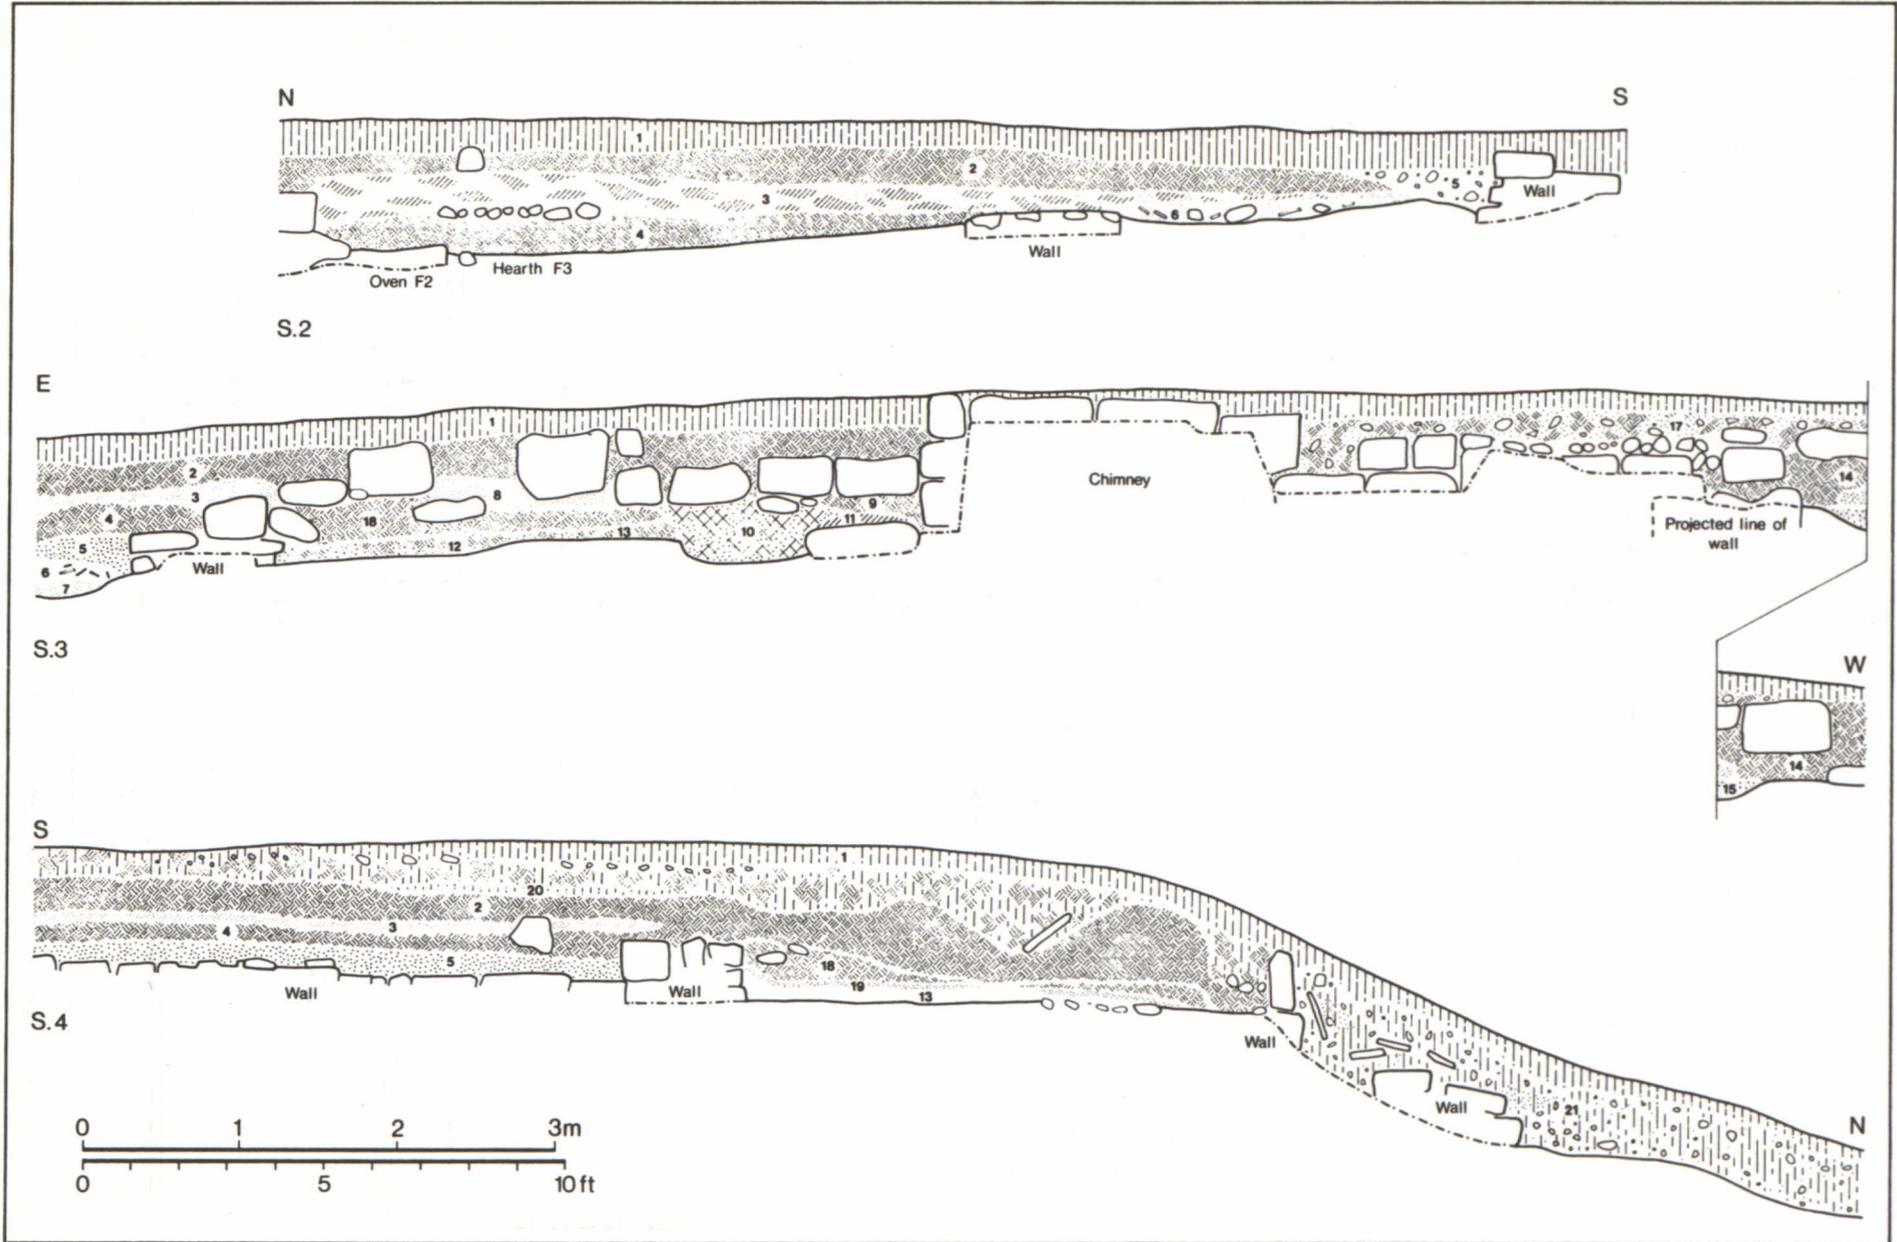
Figure 7: The excavations, sections S2-4 through kitchens. Numbered layers are described in the text.

Evidence for the walling associated with this phase is ambiguous. At the north-east corner layer 3 lapped over the inner facing stones of what was, presumably, the north side wall foundation of both phases (Fig. 7, S4). On the south side, layer 4 lapped over the inner face of the primary wall foundation, but layer 3 extended above it completely, and continued as far as the north wall of the hall building (Fig. 7, S2). On both the west and east sides there were, again, indications that the levelling and occupation layers extended over the lines of the Phase I walls (Fig. 7, S3). A partition wall running through the eastern half of the building can be attributed to this phase. Its west end, formed by two dressed rectangular blocks placed end to end, may have been the threshold of a doorway abutting the chimney stack (Plate IX). To the west of the stack, an area of cobbles edged with larger stones seems to have extended over the Phase I walls on both the west and south sides. The cobbles were underlain by a single line of large blocks of stone which may have represented a first-phase or an earlier second-phase partition.

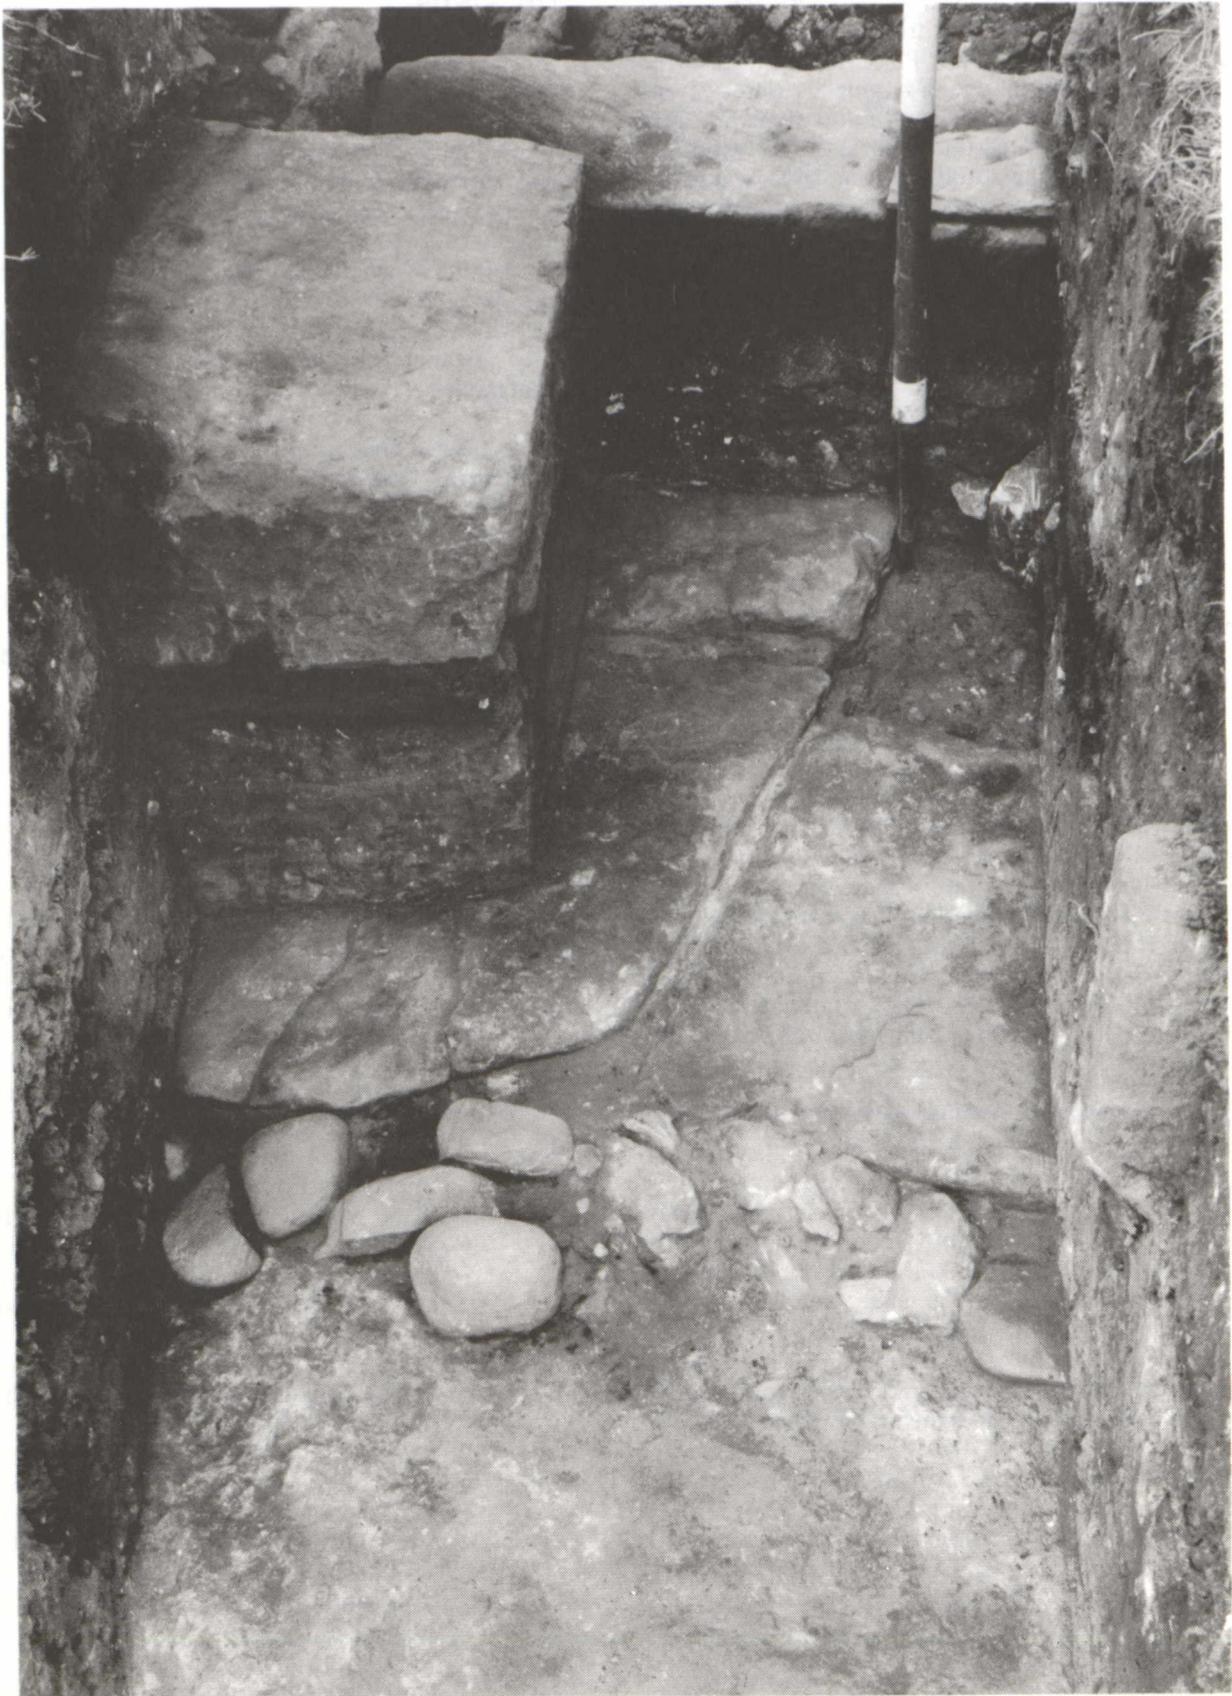
Plate IX: The kitchen Phase I oven floor (on bottom of trench) with Phase II features, including door threshold (behind ranging poles), on make-up above oven (scale in feet).

Towards the centre of the building was a feature (F2) identified as an oven (Plate IX). It was formed by a setting of stone slabs, their surface on approximately the same level as the surface of layer 12 (Fig. 7, S3). A layer of white wood-ash, layer 11, on top of the stones lends support to the idea of an enclosed oven rather than an open hearth. The stones were set in a depression which extended beyond the slabs on the east side. There, it was filled with sand and burnt clay (layer 10), and was identified as a rake-back. The edge of the depression cut not only layer 12-13, but also layer 18

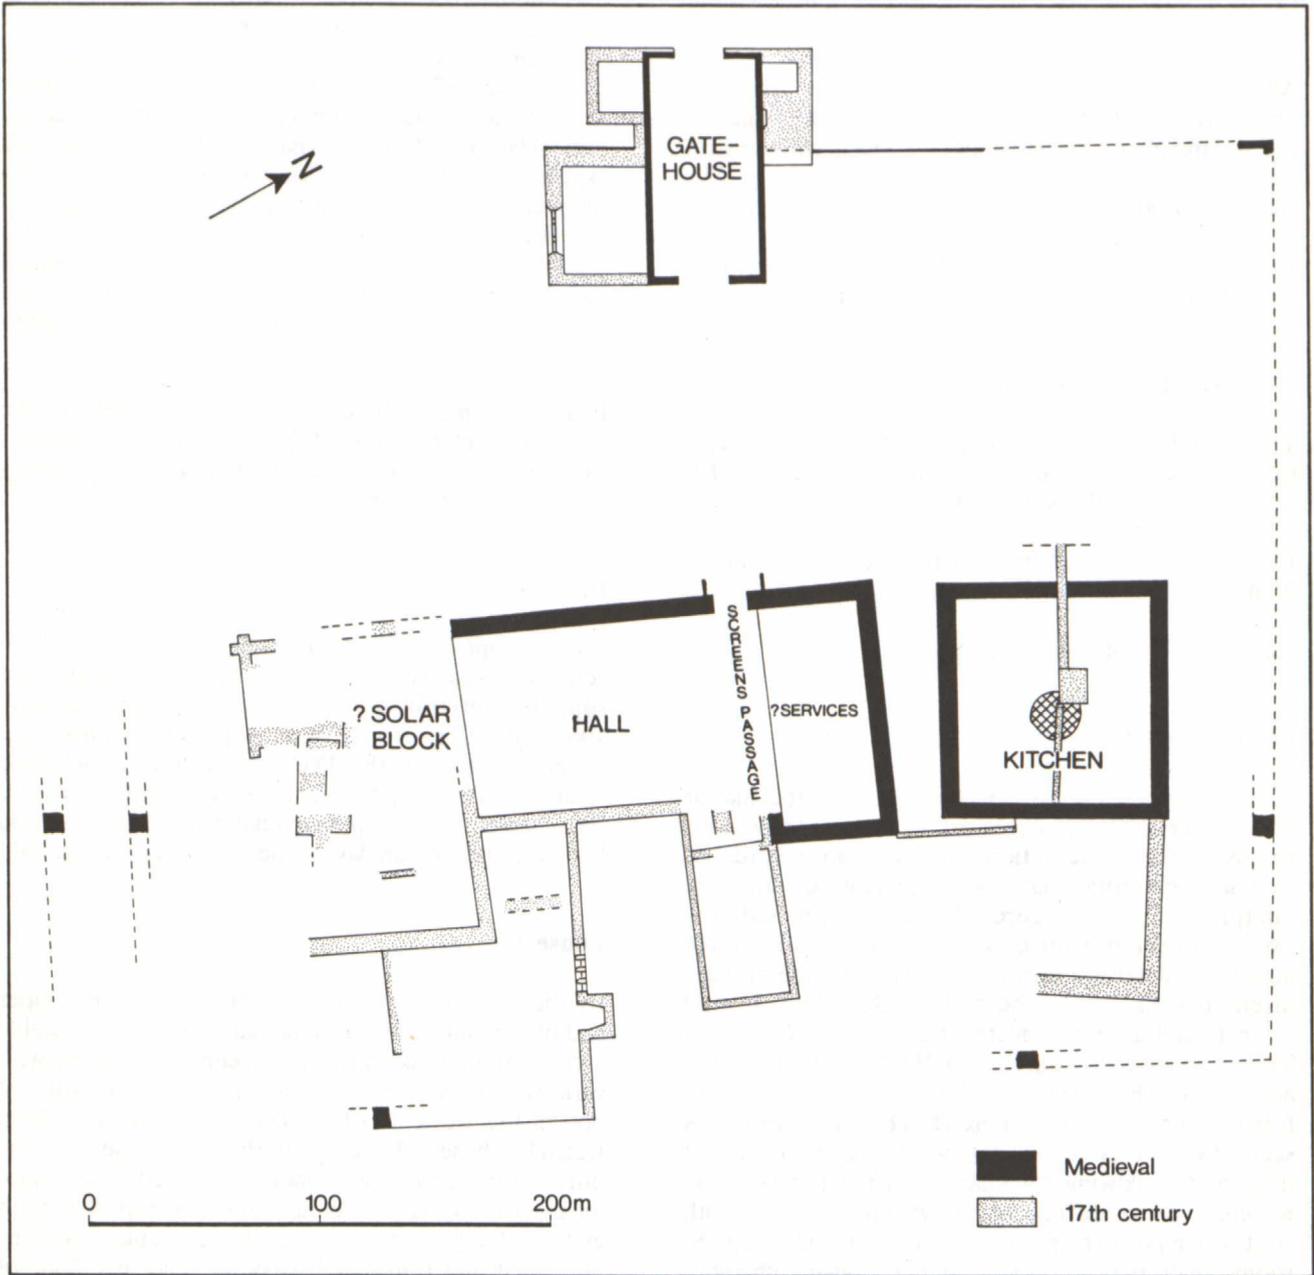
Figure 17: Interpretation plan, the structural phases.
