JOURNAL OF THE MERSEYSIDE

ARCHAEOLOGICAL SOCIETY

VOLUME 8 (FOR 1988-89)

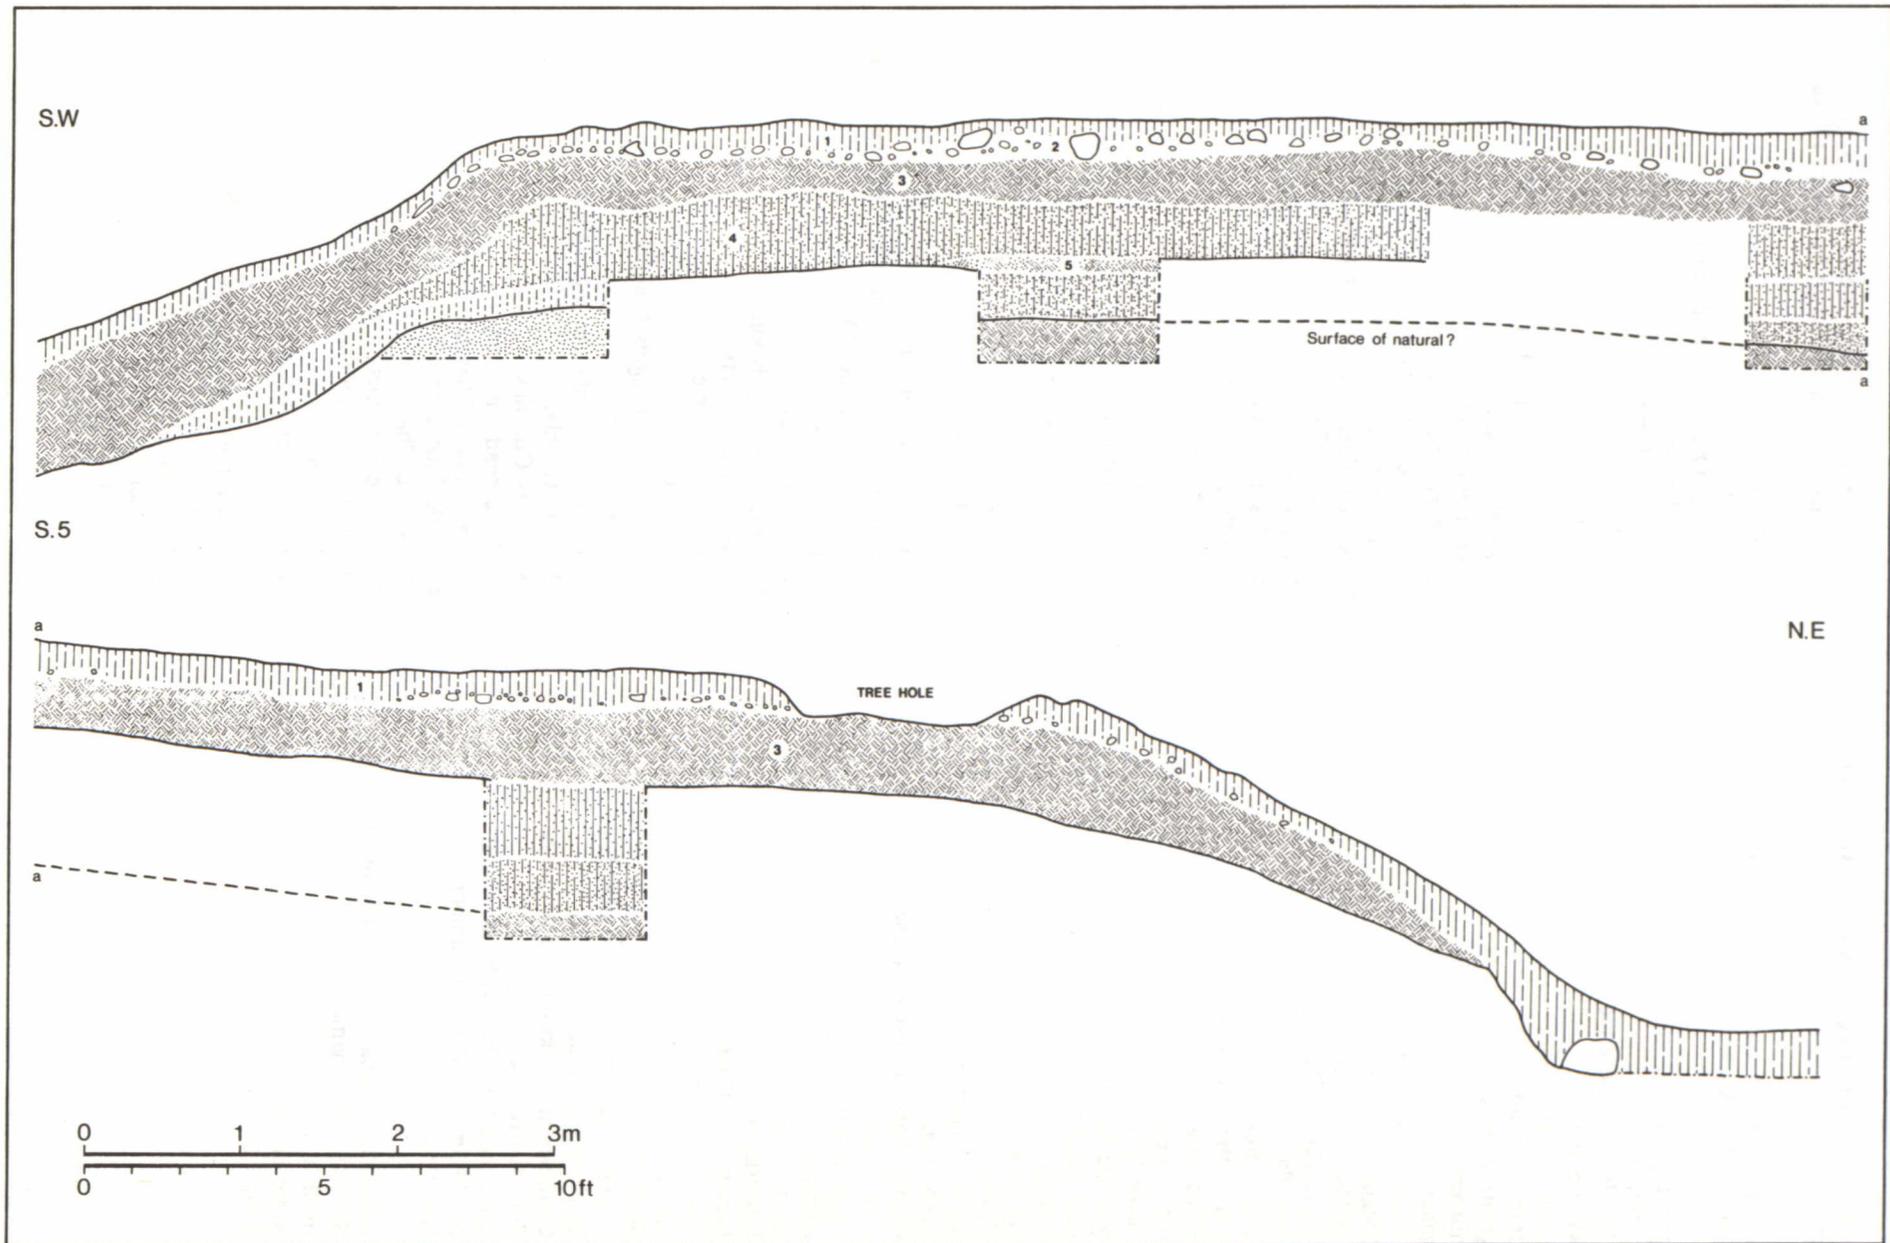
Figure 18: Wright's Moat excavation, section S5 through moated island. Numbered layers are described in the text.

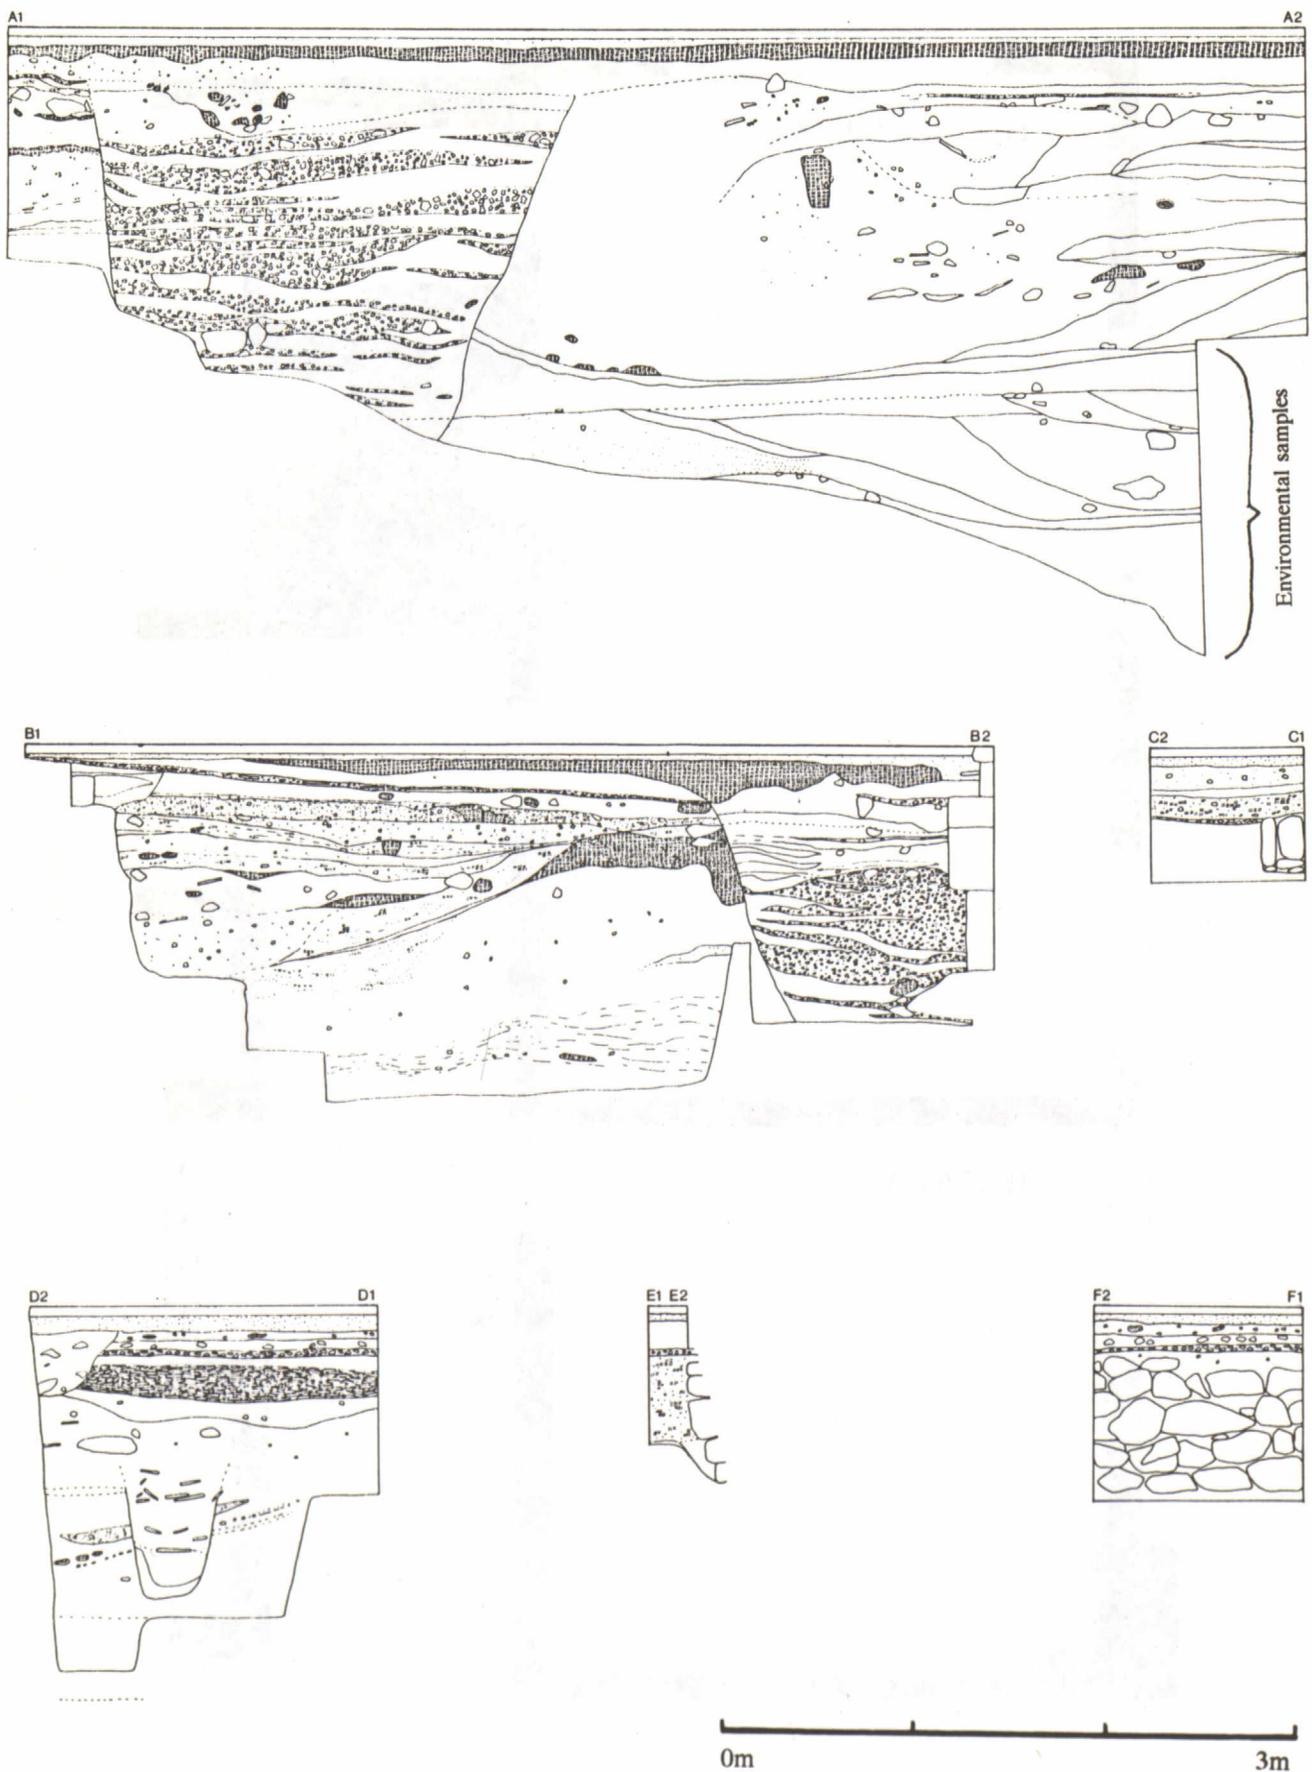
Figure 3: Section drawings (see caption opposite).

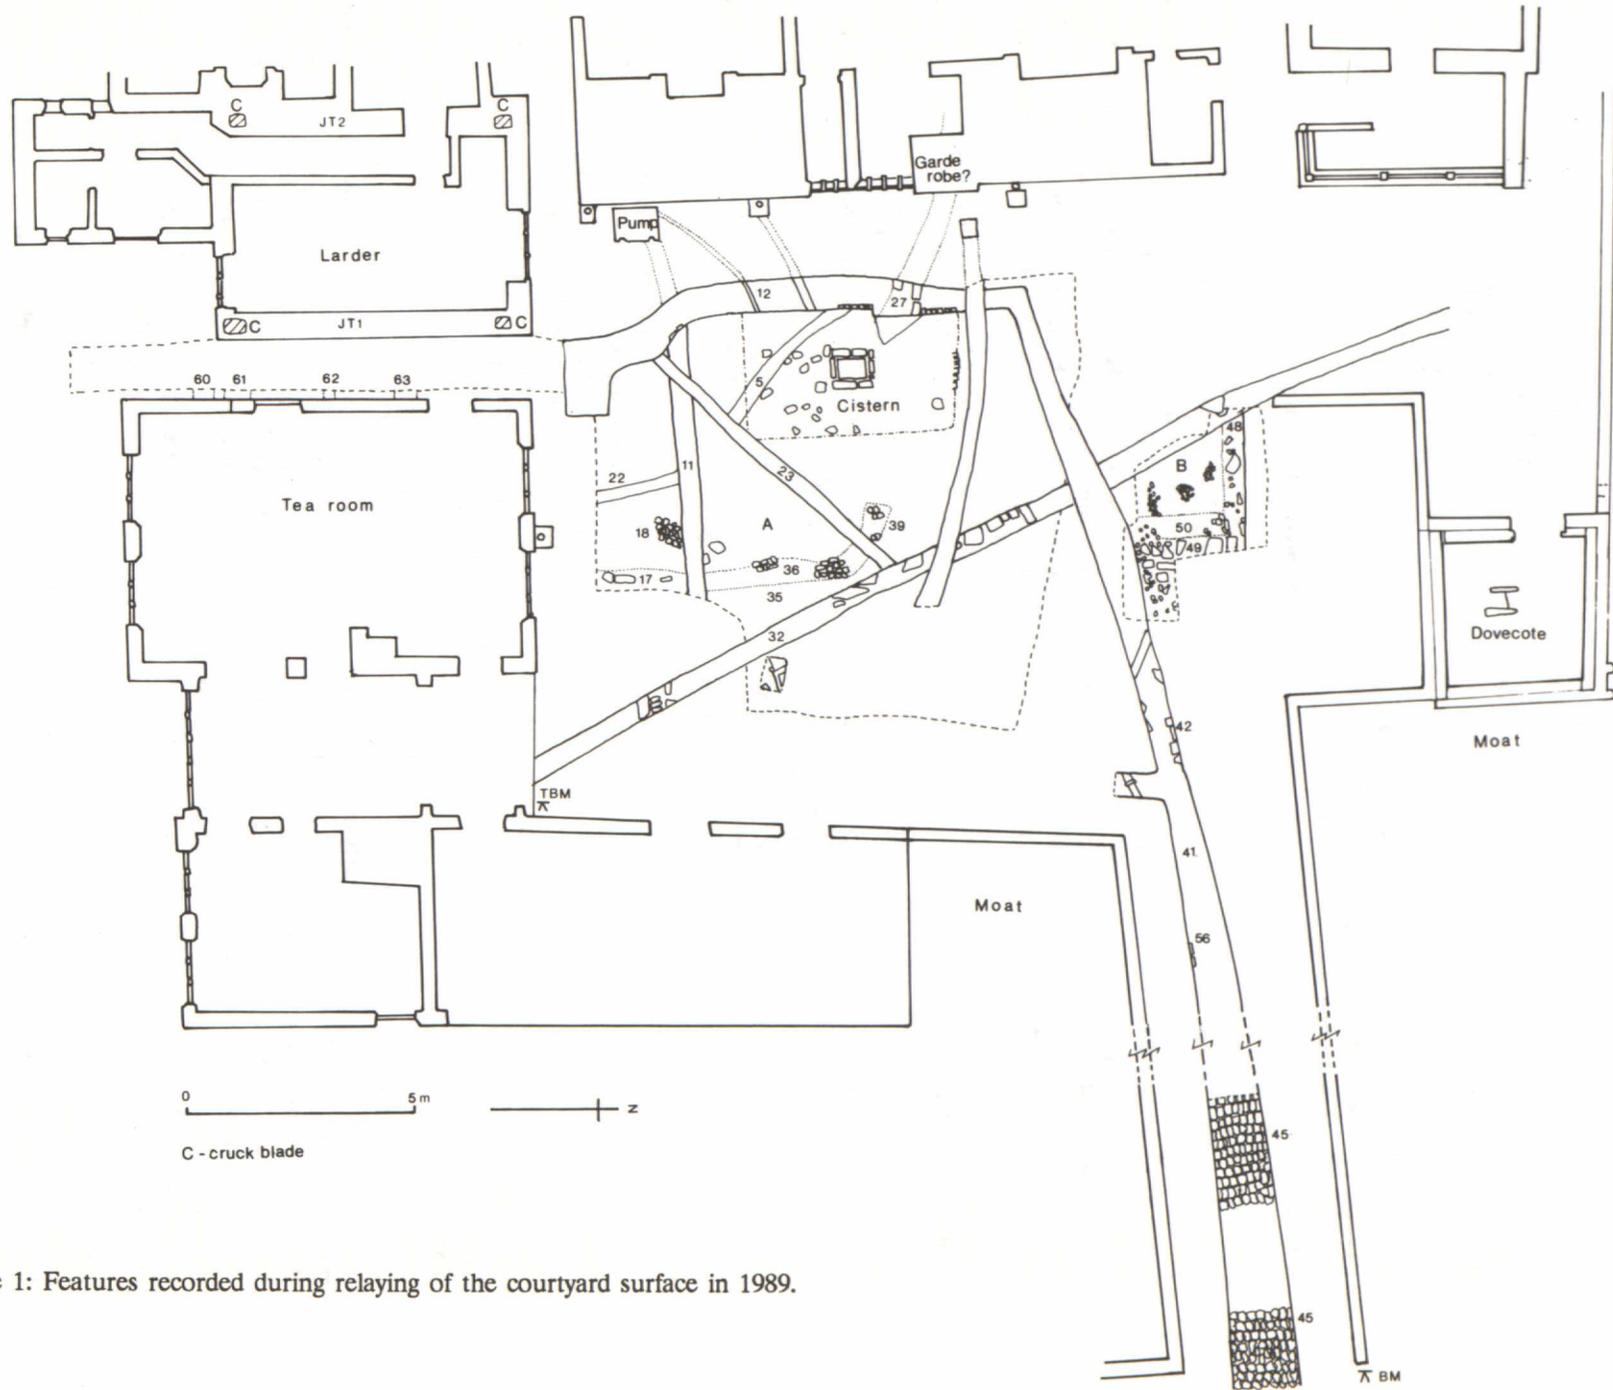
Figure 1: Features recorded during relaying of the courtyard surface in 1989.

Although highly likely, the association of structure A with a cruck-framed building (JT1, JT2) recorded in the Tea Room range (Lewis, 1988) cannot be confirmed due to the insertion of a service trench alongside the north wall of the Tea Room range. Other service trenches have effectively destroyed any possible relationship between the two structures, A and B, though in plan it appears that they might have formed a continuous line of sandstone walling across the yard.

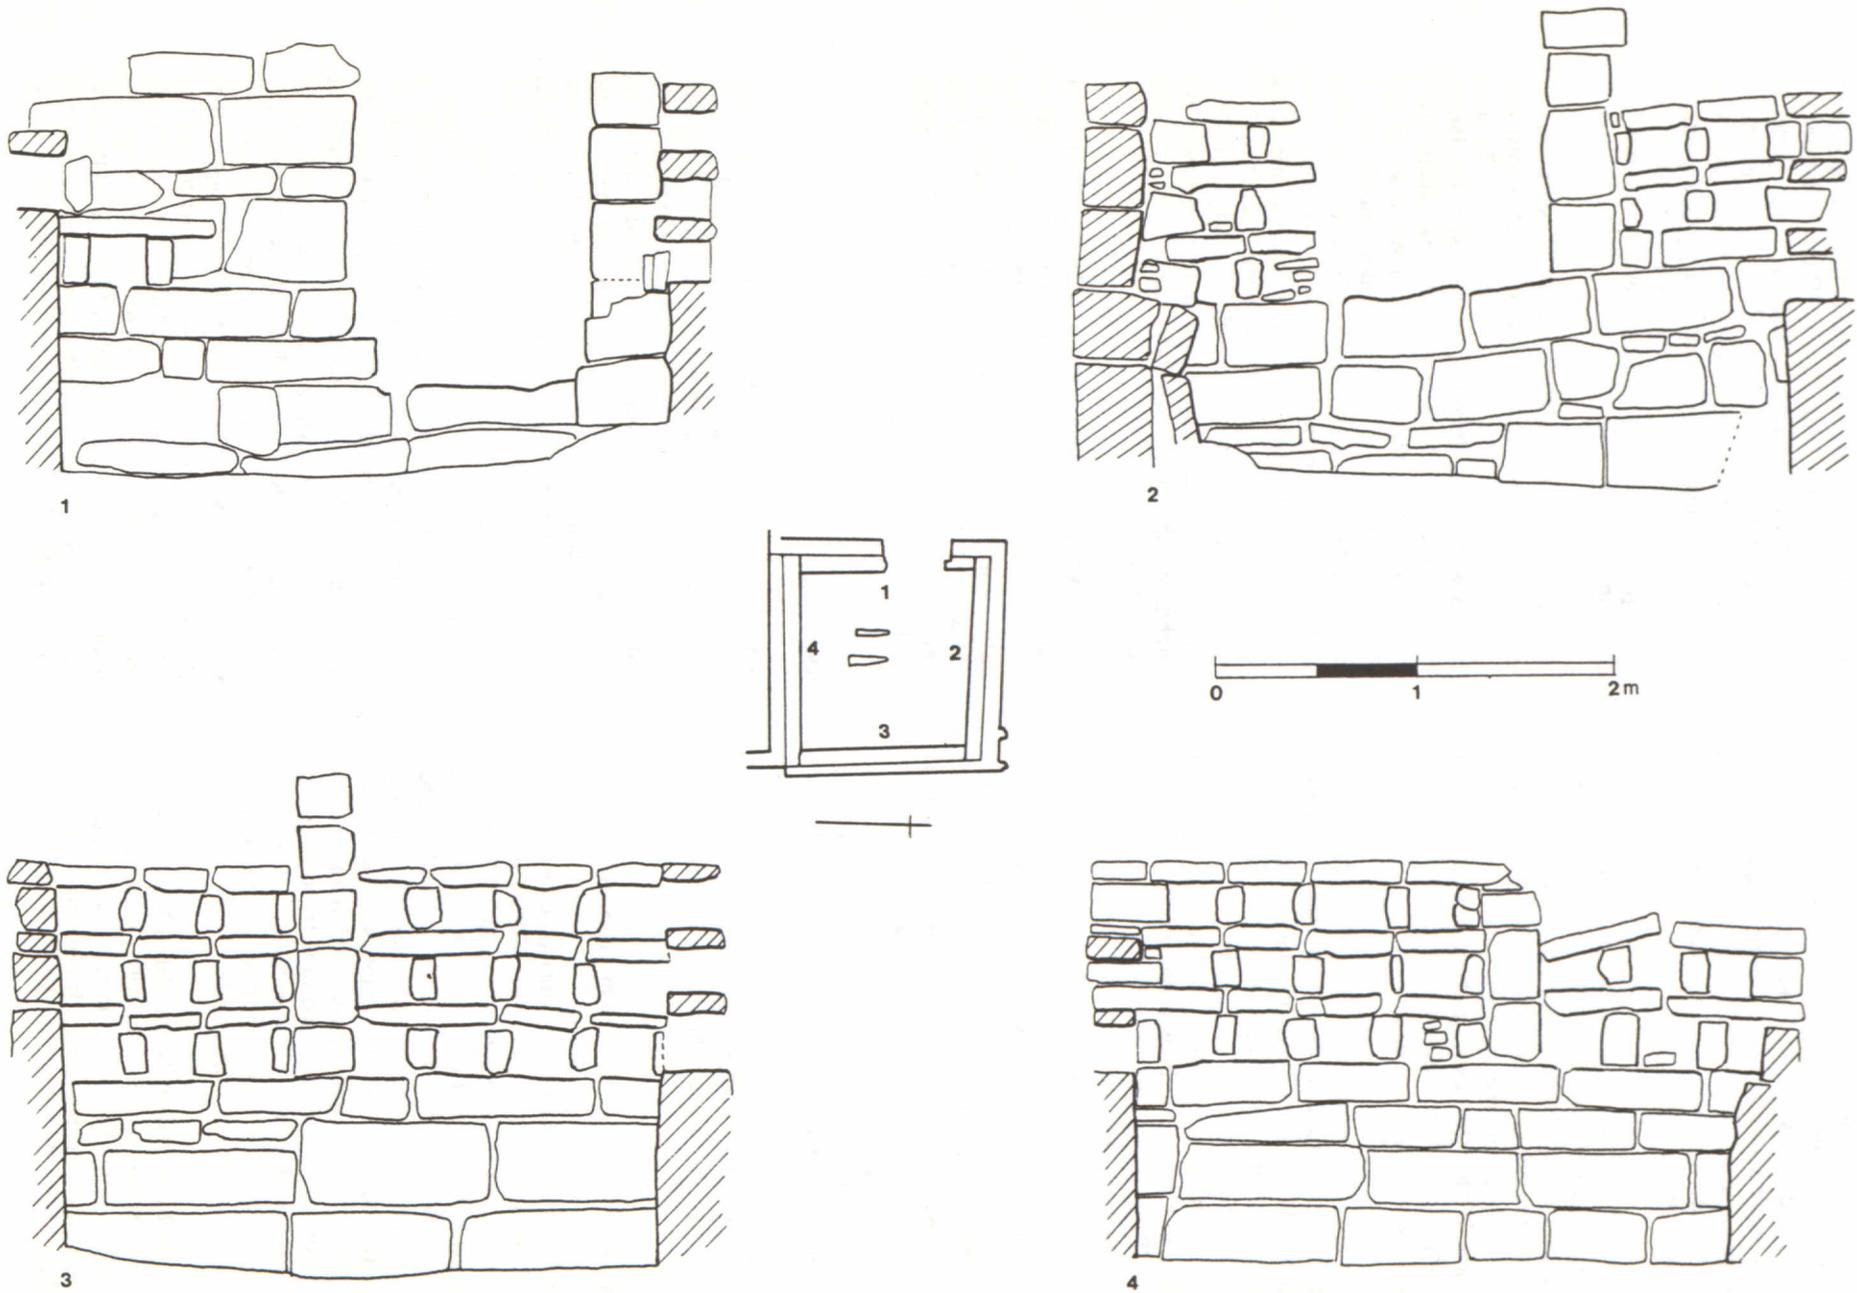
Figure 2: The dovecote: elevations (reproduced by permission of the Archaeological Survey of Merseyside).

The dovecote is approximately square in plan and stands at the north-east corner of the yard. On the outer face of the north wall is a pair of shallow buttresses between which is a recessed sandstone wall. Above the recess the wall projects slightly, and shows evidence for a blocked opening. At the base of the buttressed wall is a series of flat flagstones. West of the buttresses, at present ground level, is a drain channel which opens into the moat. Examination of the stone work on the outer face of the north wall appears to indicate that the upper courses including the buttresses, have been rebuilt upwards from the courtyard level. If so, the nesting boxes must be contemporary with or later than this rebuilding. The nesting boxes line the north, east and south walls and consist entirely of sandstone masonry which shows little indication of keying into the walls. The floor of the dovecote has been robbed out but the occasional flag of red sandstone survives beneath the walls and suggests that the south and west walls overlie an earlier feature, possibly structure B already noted above. A layer of soft mortar along the west and north walls indicates that the floor was partly re-laid at a slightly higher level than the earlier surface. A pair of linear sandstone slabs in the centre of the floor area may indicate the lining for a

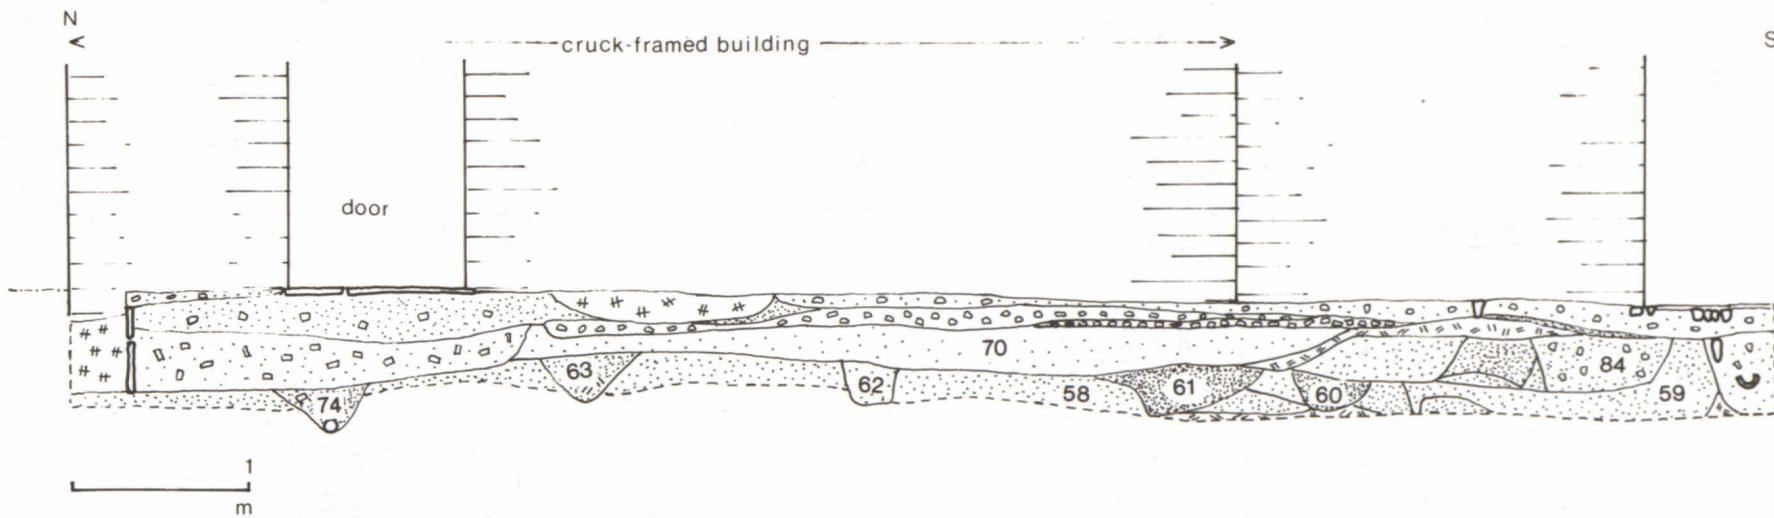
Figure 3: The Tea Room Passage: east section.

At the north end of the section there was evidence for rebuilding. This was, almost certainly, associated with the construction of the north wall of the Tea Room and a pipe trench (74) was probably inserted during this phase. This work had effectively destroyed any evidence for wall lines associated with the timber building. Following its construction the area was sealed by a
