St Catherine's Chapel, Lydiate

In 1975 a group of students from Christ's College Archaeological Society visited St. Catherine's Chapel and decided to record as fully as possible the existing fabric of the Chapel, and to consider ways of conserving the remains. Accordingly a project was undertaken to construct a ground plan (Fig. 2) and measured drawings (Fig. 10). Few of the students, studying History, have had experience of this kind of work, and so the plans must be regarded as provisional. The techniques employed included the use of a plane table and simple clinometer.

Fig. 10. St Catherine's Chapel, Lydiate. Measured drawings, 1975.

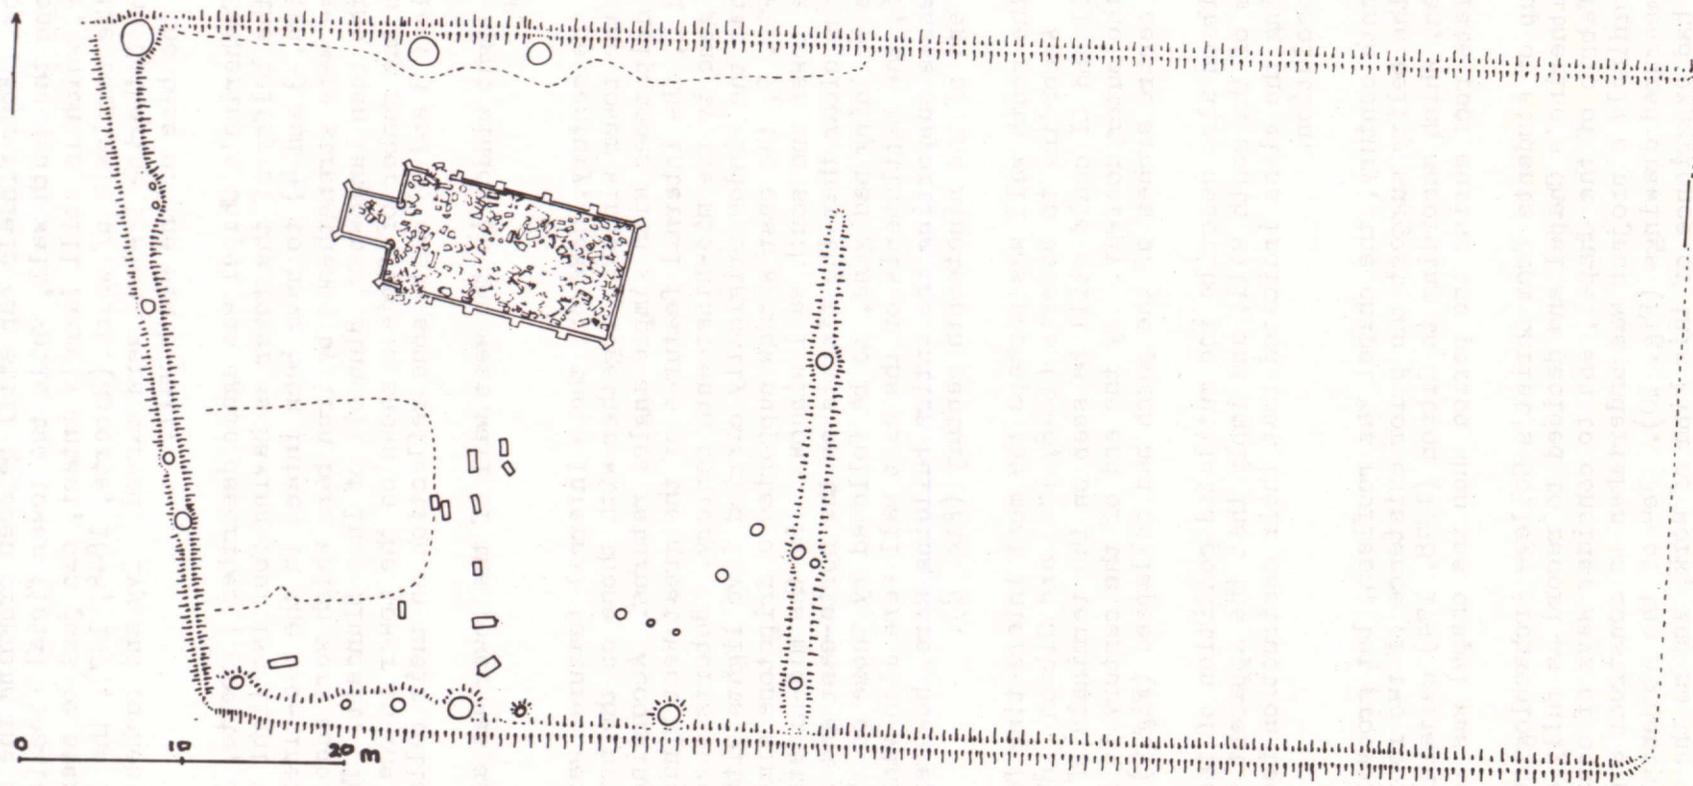
Fig. 2 St Catherine's Chapel, Lydiate.

There is little trace now of internal fittings. No certain evidence can be seen among the stones lying in the interior (Fig. 2) of the altar, or of gravestones. A number of masons' marks can be seen, some corresponding to those which occurred at Burscough Priory (Appendix II).

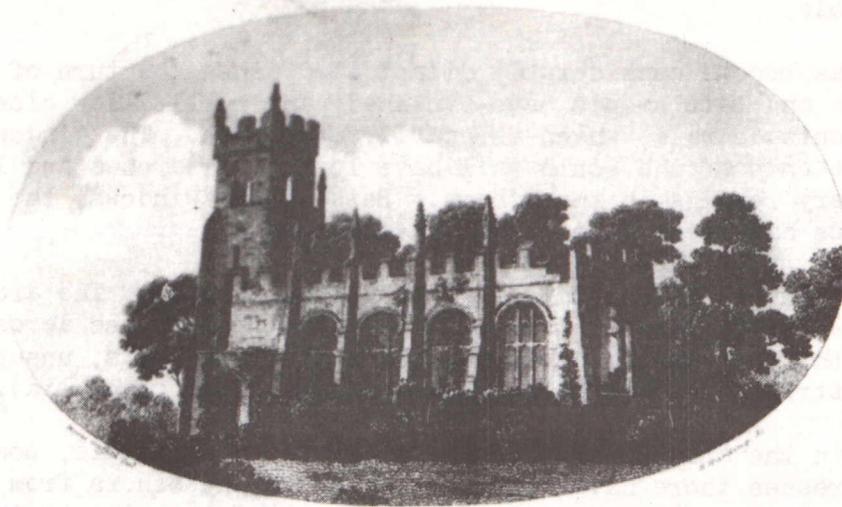
Fig. 3 St Catherine's Chapel, 1773. (Pennant, 1801, 51)

According to the engraving (Fig. 3), the Chapel, although roofless, still retained unbroken the tracery of all the windows except the big east window. Four finials can still be seen crowning the stepped buttresses along the south wall, while two tower finials remain. Over the porch door, which is still largely intact, can just be seen the dripstone on the terminals of which (Roberts, 1848, 147), the initials of Lawrence and Catherine Ireland were carved. Ivy and bushes have encroached at the base of the south wall.

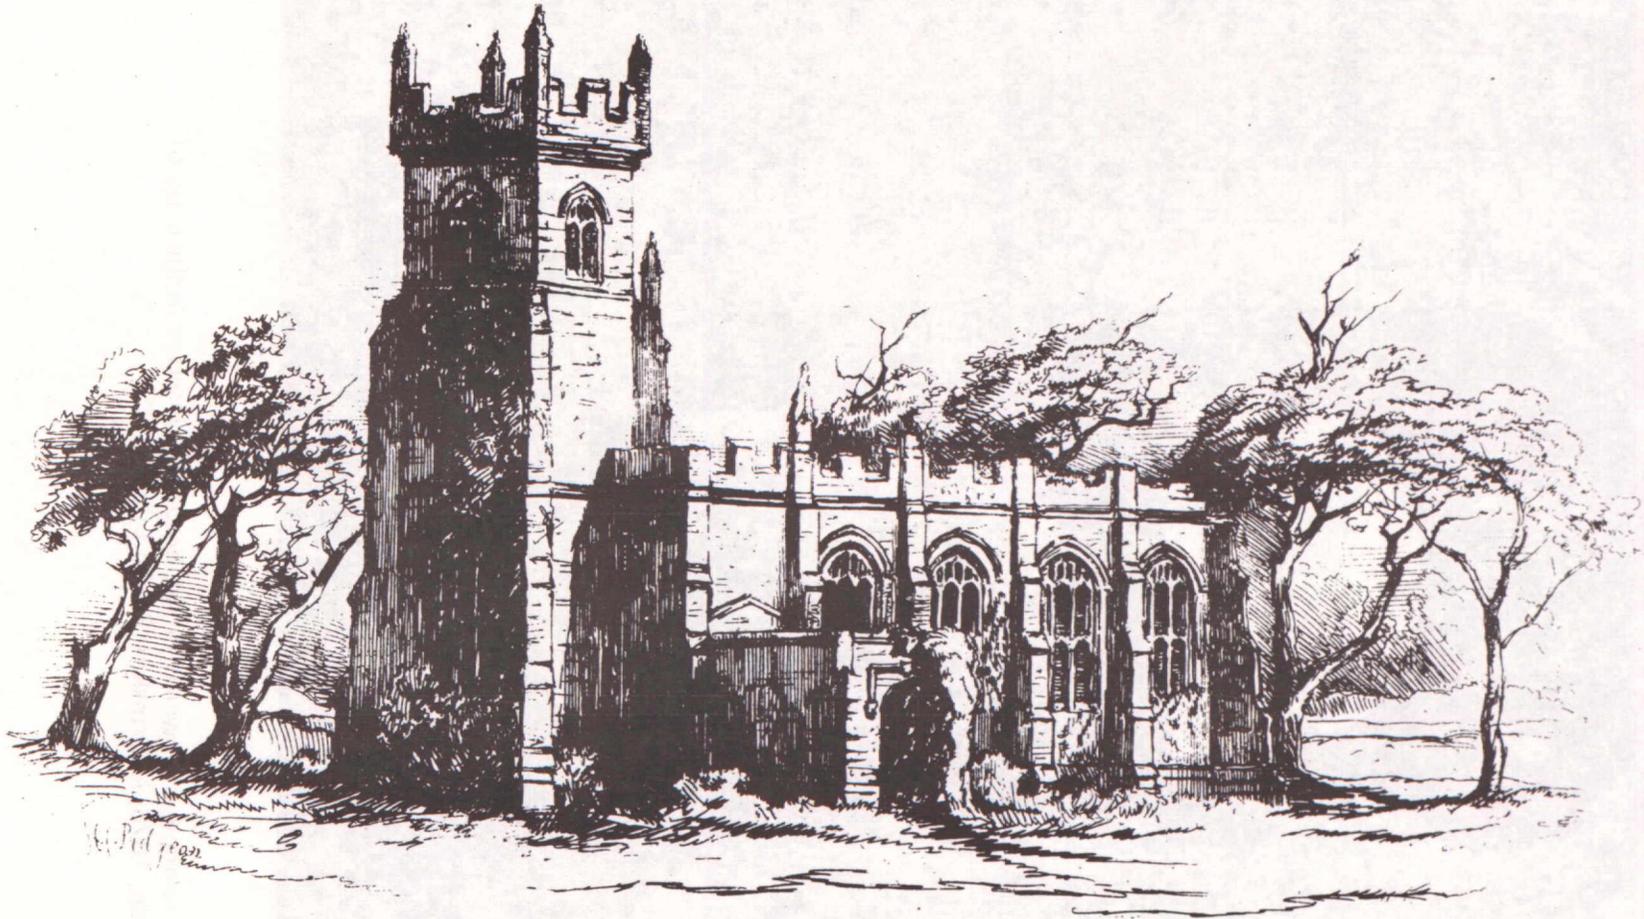
Fig. 4. St Catherine's Chapel in 1848 (Roberts, 1848, op. p.147)

In 1848, St. Catherine's Chapel was again described (Roberts, 1848, 146-153). He described the belfry of the tower as having four two light windows, which seem (Figs. 3 and 4) to have been intact in the mid-nineteenth century. These were strengthened by iron bars which were added about this time by the then landowner, Blundell of Ince Blundell. The discrepancy in the number of finials shown on the tower in the two engravings (Figs. 3 and 4) casts some reflection on their reliability.

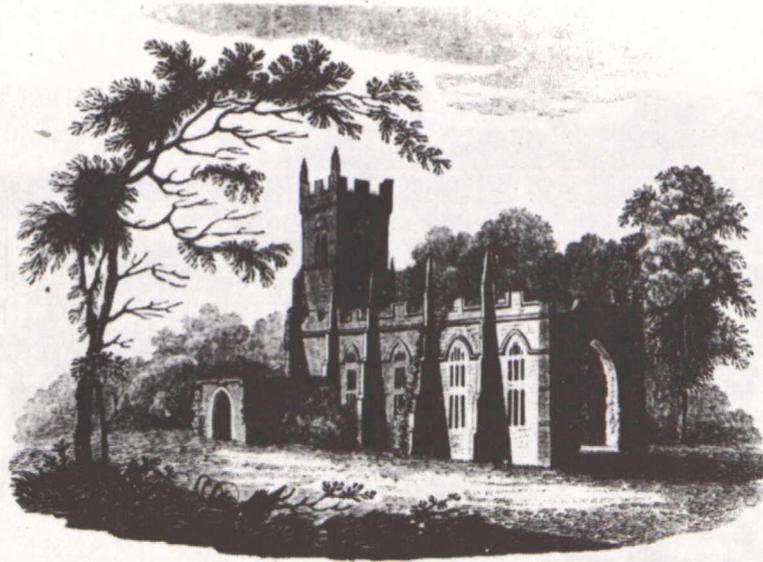
Fig. 6. The chapel in the mid-nineteenth century (Binns Collection II)

By the end of the century, however, these internal features were vanishing (Fig. 5). All the tower windows, together with those on the south wall, still carried dripstones with simple angled returns. According to Figs. 3, 5 and 6, the internal features of the great west window behind the altar had gone by the mid-nineteenth century. Roberts suggests (1848, 147) that the window originally carried five lights with tracery. According to Fig. 7, the east window supported a dripstone similar to those over the tower and south wall windows. By the mid-nineteenth century it seems clear that the finials on the north-east and south-east corners of the building had gone, to be followed by those on the south wall. By 1876, the battlements of the east wall were also vanishing. The stepped buttresses supporting the entire building were, however, still intact at the end of the nineteenth century (Fig. 8).
